Machine Id
70010
Component
Hoist
Fluid
HITACHI SUPER EH56HBW (--- GAL)

Customer Id: VMEGUE
Sample No.: WC0876931
Lab Number: 02607511
Test Package: IND 2

OIL ANALYSIS REPORT

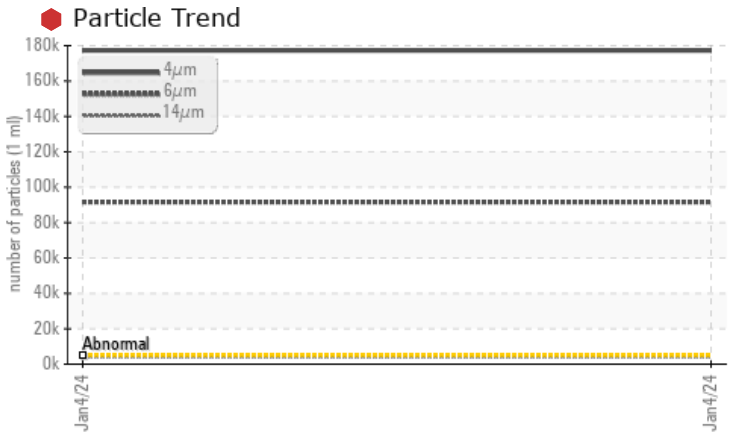
COMPONENT CONDITION SUMMARY

Sample Status				**SEVERE**	---	---
Particles >4µm		ASTM D7647	>5000	**177220**	---	---
Particles >6µm		ASTM D7647	>1300	**91602**	---	---
Particles >14µm		ASTM D7647	>160	**4324**	---	---
Particles >21µm		ASTM D7647	>40	**580**	---	---
Oil Cleanliness		ISO 4406 (c)	>19/17/14	**25/24/19**	---	---

We advise that you check all areas where contaminants can enter the system. We advise that you perform a filter service, and use off-line filtration to improve the cleanliness of the system fluid. The air breather requires service. If unrated, we recommend that you replace with a suitable micron rated and/or desiccant air breather. If rated, we recommend that you service/replace the breather. Resample in 30-45 days to monitor this situation. NOTE: Please provide information regarding reservoir capacity, filter type and micron rating with next sample.

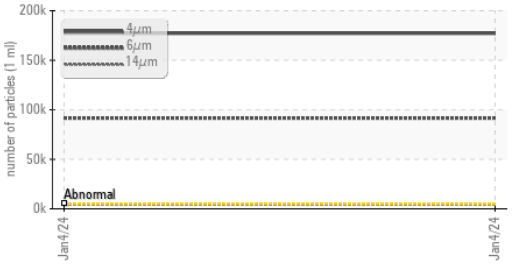
Particle Trend

There is a high amount of particulates (2 to 100 microns in size) present in the oil.

FLUID CLEANLINESS		method	limit/base	current	history1	history2
Particles >4µm		ASTM D7647	>5000	**177220**	---	---
Particles >6µm		ASTM D7647	>1300	**91602**	---	---
Particles >14µm		ASTM D7647	>160	**4324**	---	---
Particles >21µm		ASTM D7647	>40	**580**	---	---
Particles >38µm		ASTM D7647	>10	**15**	---	---
Particles >71µm		ASTM D7647	>3	**1**	---	---
Oil Cleanliness		ISO 4406 (c)	>19/17/14	**25/24/19**	---	---
