Customer Id: NEWSTJ
Sample No.: WC0706214
Lab Number: 02607537
Test Package: IND 2

OIL ANALYSIS REPORT

Machine Id
RBK G2 UGBR/THBR
Component
Bearing
Fluid
MOBIL DTE OIL HVY MEDIUM (55 GAL)

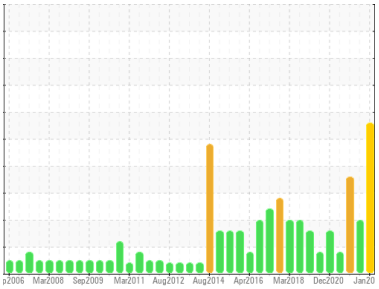
Sample Rating Trend

Sample Status				**SEVERE**	ABNORMAL	SEVERE
Particles >4µm		ASTM D7647	>10000	**107703**	61955	107510
Particles >6µm		ASTM D7647	>2500	**25498**	13089	25326
Particles >14µm		ASTM D7647	>160	**1243**	521	937
Particles >21µm		ASTM D7647	>40	**267**	99	201
Oil Cleanliness		ISO 4406 (c)	>20/18/14	**24/22/17**	23/21/16	24/22/17
White Metal	scalar	Visual*	NONE	**LIGHT**	NONE	NONE
PrtFilter

We advise that you check all areas where contaminants can enter the system. We advise that you check for visible metal particles in the oil. We advise that you perform a filter service, and use off-line filtration to improve the cleanliness of the system fluid. The air breather requires service. If unrated, we recommend that you replace with a suitable micron rated and/or desiccant air breather. If rated, we recommend that you service/replace the breather. Resample in 30-45 days to monitor this situation.

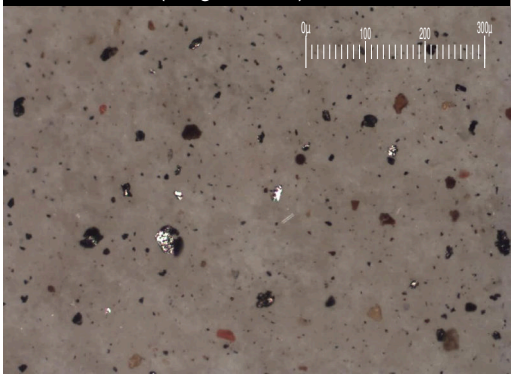
Particle Filter (Magn: 100 x)

Light concentration of visible metal present.

There is a high amount of particulates (2 to 100 microns in size) present in the oil.

We advise that you check all areas where contaminants can enter the system. We advise that you check for visible metal particles in the oil. We advise that you perform a filter service, and use off-line filtration to improve the cleanliness of the system fluid. The air breather requires service. If unrated, we recommend that you replace with a suitable micron rated and/or desiccant air breather. If rated, we recommend that you service/replace the breather. Resample in 30-45 days to monitor this situation.

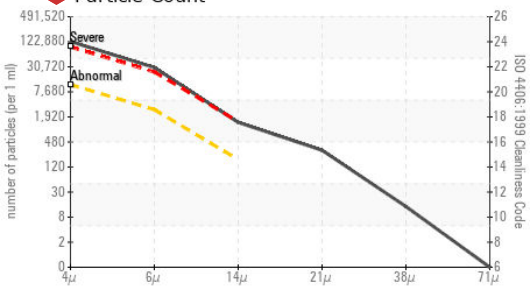
Particle Count

FLUID CLEANLINESS		method	limit/base	current	history1	history2
Particles >4µm		ASTM D7647	>10000	**107703**	61955	107510
Particles >6µm		ASTM D7647	>2500	**25498**	13089	25326
Particles >14µm		ASTM D7647	>160	**1243**	521	937
Particles >21µm		ASTM D7647	>40	**267**	99	201
Particles >38µm		ASTM D7647	>10	**12**	3	7
Particles >71µm		ASTM D7647	>3	**0**	1	0
Oil Cleanliness		ISO 4406 (c)	>20/18/14	**24/22/17**	23/21/16	24/22/17

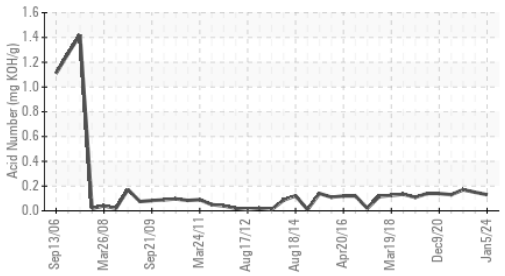
The AN level is acceptable for this fluid. The oil is still serviceable provided that the contaminant(s) can be reduced to acceptable levels.

FLUID DEGRADATION		method	limit/base	current	history1	history2
Acid Number (AN)	mg KOH/g	ASTM D974*		**0.13**	0.15	0.17
