OIL ANALYSIS REPORT

Machine Id
Timm Plunger 2
Component
Gearbox
Fluid
SHELL OMALA 68 (1 LTR)

FERROGRAPHY REPORT

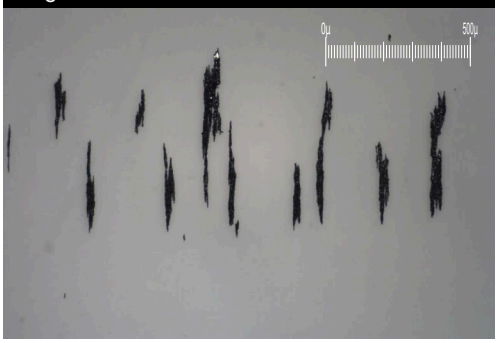
Magn: 50x Illum: RW

All component wear rates are normal. The ferrography results are normal indicating no abnormal wear in the system.
