Area
BRUCE B/0B/54300
Machine Id
0B-54300-EPG2-CP1-OIL
Component
Compressor
Fluid
ESSO NUTO H ISO 150 (--- GAL)

Customer Id: BRUTIV
Sample No.: WC0642725
Lab Number: 02608208
Test Package: IND 2

OIL ANALYSIS REPORT

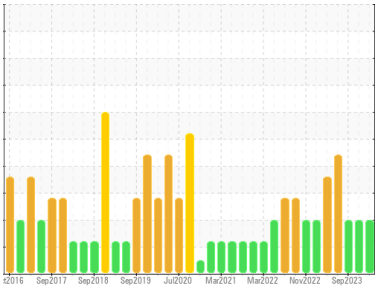
Sample Rating Trend

ISO

Sample Status				**SEVERE**	SEVERE	SEVERE
Particles >4µm		ASTM D7647	>10000	**103030**	104305	142015
Particles >6µm		ASTM D7647	>2500	**8717**	10145	19744
Oil Cleanliness		ISO 4406 (c)	>20/18/15	**24/20/12**	24/21/11	24/21/12
PrtFilter

Check seals and/or filters for points of contaminant entry. The air breather requires service. If unrated, we recommend that you replace with a suitable micron rated and/or desiccant air breather. If rated, we recommend that you service/replace the breather. We recommend you service the filters on this component. Resample in 30-45 days to monitor this situation.

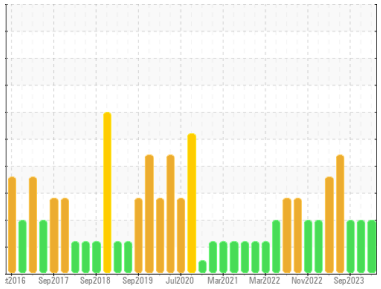
Sample Rating Trend

ISO

There is a high amount of silt (particulates < 14 microns in size) present in the oil. The water content is negligible.

The AN level is acceptable for this fluid. The oil is still serviceable provided that the contaminant(s) can be reduced to acceptable levels.

Check seals and/or filters for points of contaminant entry. The air breather requires service. If unrated, we recommend that you replace with a suitable micron rated and/or desiccant air breather. If rated, we recommend that you service/replace the breather. We recommend you service the filters on this component. Resample in 30-45 days to monitor this situation.

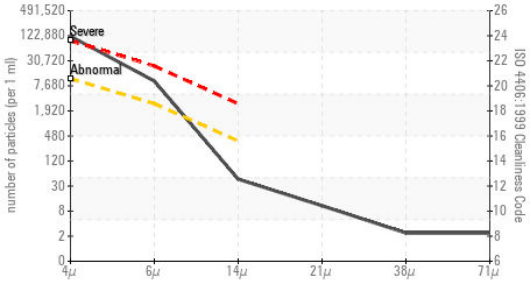
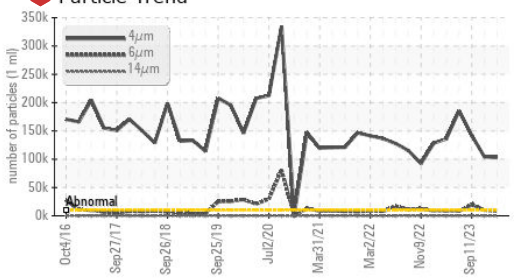
FLUID CLEANLINESS	method	limit/base	current	history1	history2
Particles >4µm	ASTM D7647	>10000	**103030**	104305	142015
Particles >6µm	ASTM D7647	>2500	**8717**	10145	19744
Particles >14µm	ASTM D7647	>320	**39**	18	25
Particles >21µm	ASTM D7647	>80	**9**	2	3
Particles >38µm	ASTM D7647	>20	**2**	0	0
Particles >71µm	ASTM D7647	>4	**2**	0	0
Oil Cleanliness	ISO 4406 (c)	>20/18/15	**24/20/12**	24/21/11	24/21/12

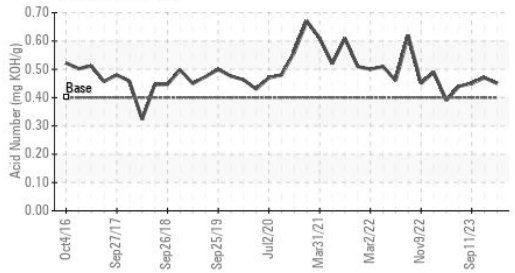
FLUID DEGRADATION		method	limit/base	current	history1	history2
Acid Number (AN)	mg KOH/g	ASTM D974*	.40	**0.45**	0.47	0.45

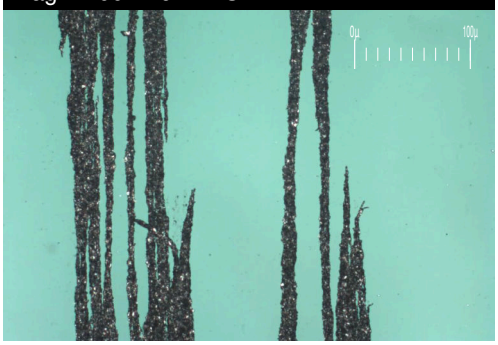
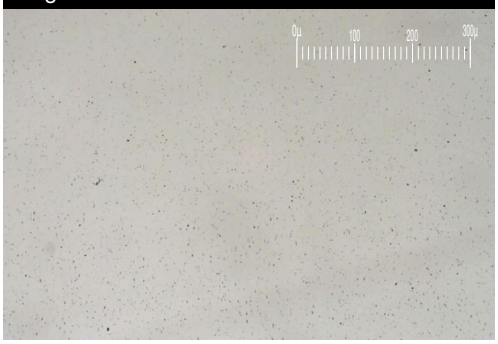
Magn: 200x Illum: BC

All component wear rates are normal. The ferrography results are normal indicating no abnormal wear in the system.
