PROBLEM SUMMARY

Area
(ZONE3) BRUCE A/1/34710
Machine Id
1-34710-P1-P OB Ball/Sleeve
Component
Outboard Bearing
Fluid
MOBIL DTE 732 (--- GAL)

OIL ANALYSIS REPORT

FERROGRAPHY REPORT

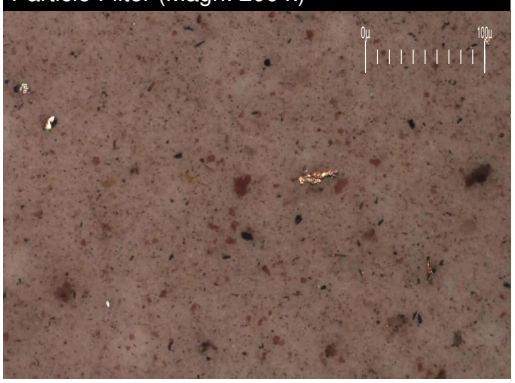
Particle Filter (Magn: 200 x)

There is a high amount of silt (particulates < 14 microns in size) present in the oil. The water content is negligible. The system cleanliness code is much higher than the acceptable limit for the target ISO 4406 cleanliness code.

Check seals and/or filters for points of contaminant entry. The air breather requires service. If unrated, we recommend that you replace with a suitable micron rated and/or desiccant air breather. If rated, we recommend that you service/replace the breather. We recommend you service the filters on this component. Resample in 30-45 days to monitor this situation. NOTE: Please provide information regarding reservoir capacity, filter type and micron rating with next sample.

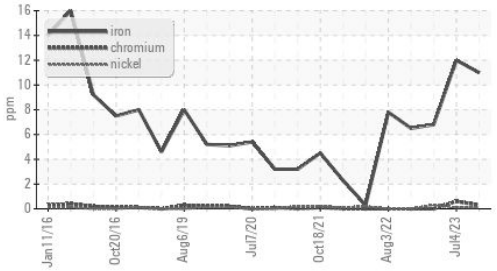
Ferrous Alloys

Iron ppm levels are abnormal. The low ferrous density (PQ) index indicates the wear metal levels are due to corrosion. The ferrography results are normal indicating no abnormal wear in the system.

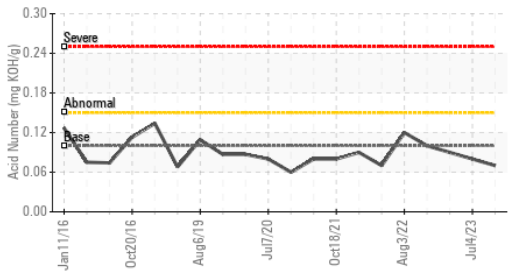
Acid Number

The AN level is acceptable for this fluid. The oil is no longer serviceable as a result of the abnormal and/or severe wear.

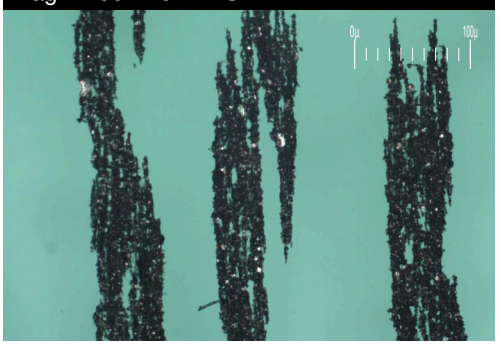
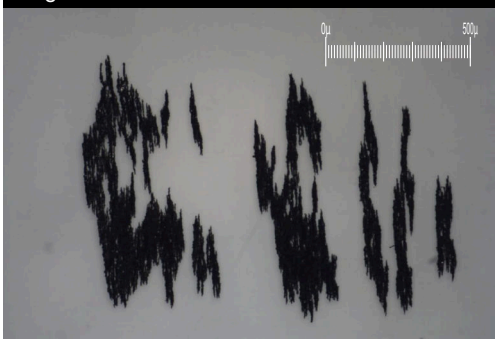
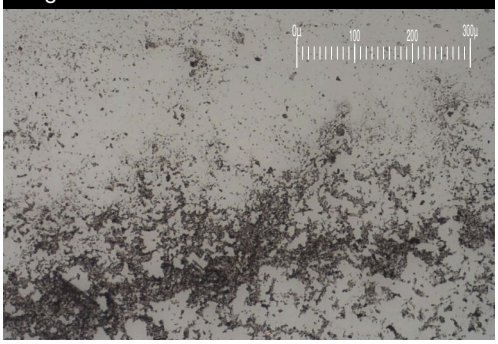
Iron ppm levels are abnormal. The low ferrous density (PQ) index indicates the wear metal levels are due to corrosion. The ferrography results are normal indicating no abnormal wear in the system.
