OIL ANALYSIS REPORT

Machine Id
DODGE CVI-I
Component
Gasoline Engine
Fluid
MOBIL 1 5W30 (--- GAL)

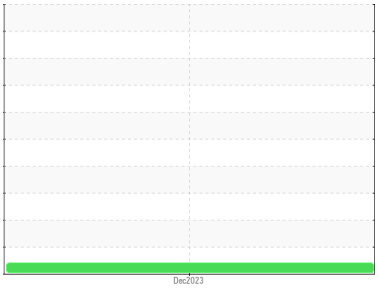
Sample Rating Trend

VISCOSITY

Fluid Condition
The BN result indicates that there is suitable alkalinity remaining in the oil. Viscosity of sample indicates oil is within SAE 20 range, advise investigate. The condition of the oil is suitable for further service.

FLUID PROPERTIES		method	limit/base	current	history1	history2
Visc @ 100°C	cSt	ASTM D7279(m)	11.3	▲ **8**	---	---

Recommendation
No corrective action is recommended at this time. Resample at the next service interval to monitor.
