PROBLEM SUMMARY

Area
Lime Kilns Route #1
Machine Id
102371 Kiln #3 Feed Table Hydraulics
Component
Hydraulic System
Fluid
ESSO NUTO H ISO 68 (30 GAL)

OIL ANALYSIS REPORT

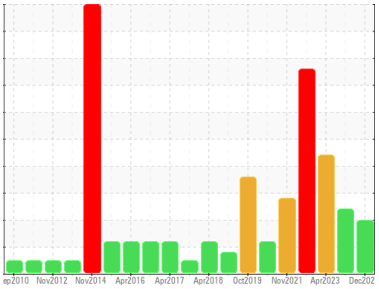
Sample Rating Trend

Sample Status				**SEVERE**	SEVERE	SEVERE
Particles >4µm		ASTM D7647	>5000	**62367**	89411	84744
Particles >6µm		ASTM D7647	>1300	**3132**	9209	12343
Oil Cleanliness		ISO 4406 (c)	>19/17/14	**23/19/14**	24/20/15	24/21/16

Check seals and/or filters for points of contaminant entry. The air breather requires service. If unrated, we recommend that you replace with a suitable micron rated and/or desiccant air breather. If rated, we recommend that you service/replace the breather. We recommend you service the filters on this component. Resample in 30-45 days to monitor this situation.

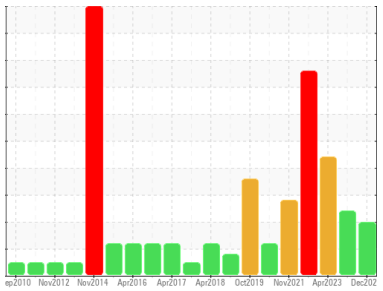
Sample Rating Trend

There is a high amount of silt (particulates < 14 microns in size) present in the oil.

The AN level is acceptable for this fluid. The oil is still serviceable provided that the contaminant(s) can be reduced to acceptable levels.

Check seals and/or filters for points of contaminant entry. The air breather requires service. If unrated, we recommend that you replace with a suitable micron rated and/or desiccant air breather. If rated, we recommend that you service/replace the breather. We recommend you service the filters on this component. Resample in 30-45 days to monitor this situation.

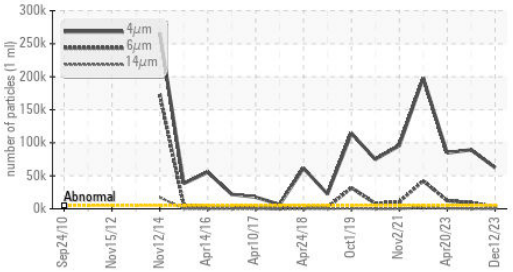
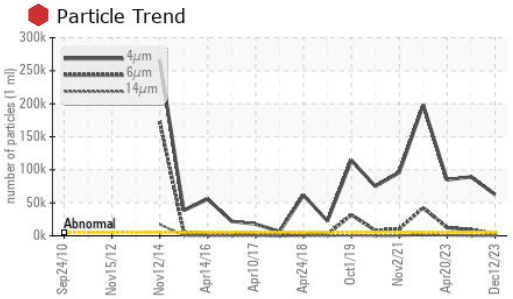
Particle Trend

FLUID CLEANLINESS		method	limit/base	current	history1	history2
Particles >4µm		ASTM D7647	>5000	**62367**	89411	84744
Particles >6µm		ASTM D7647	>1300	**3132**	9209	12343
Particles >14µm		ASTM D7647	>160	**102**	185	637
Particles >21µm		ASTM D7647	>40	**23**	32	140
Particles >38µm		ASTM D7647	>10	**1**	1	2
Particles >71µm		ASTM D7647	>3	**0**	1	0
Oil Cleanliness		ISO 4406 (c)	>19/17/14	**23/19/14**	24/20/15	24/21/16

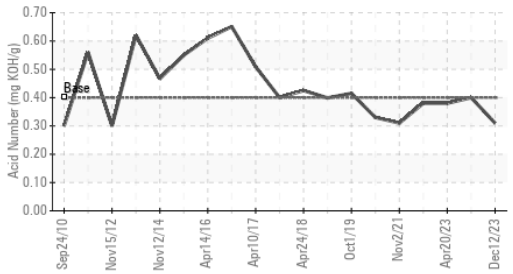
FLUID DEGRADATION		method	limit/base	current	history1	history2
Acid Number (AN)	mg KOH/g	ASTM D974*	.40	**0.31**	0.40	0.38

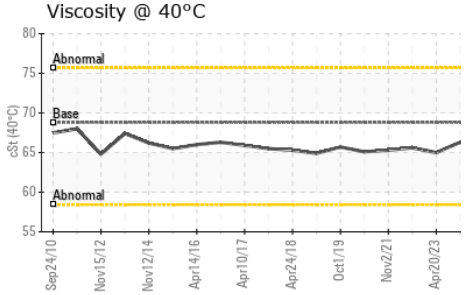
Viscosity @ 40°C

FLUID PROPERTIES		method	limit/base	current	history1	history2
Visc @ 40°C	cSt	ASTM D7279(m)	68.8	**66.2**	66.3	65.0

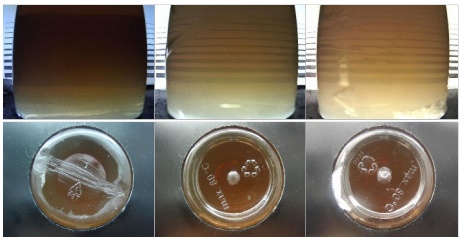
SAMPLE IMAGES	method	limit/base	current	history1	history2
Color					
Bottom

VISUAL		method	limit/base	current	history1	history2
White Metal	scalar	Visual*	NONE	**NONE**	NONE	NONE
Yellow Metal	scalar	Visual*	NONE	**NONE**	NONE	NONE
Precipitate	scalar	Visual*	NONE	**VLITE**	NONE	NONE
Silt	scalar	Visual*	NONE	**NONE**	NONE	NONE
Debris	scalar	Visual*	NONE	**NONE**	NONE	NONE
Sand/Dirt	scalar	Visual*	NONE	**NONE**	NONE	NONE
Appearance	scalar	Visual*	NORML	**NORML**	NORML	NORML
Odor	scalar	Visual*	NORML	**NORML**	NORML	NORML
Emulsified Water	scalar	Visual*	>0.05	**NEG**	NEG	NEG
Free Water	scalar	Visual*		**NEG**	NEG	NEG

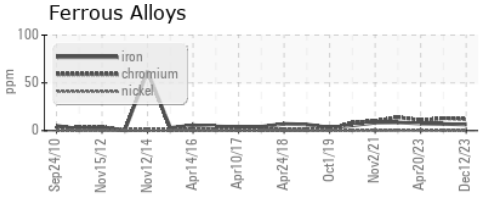
Ferrous Alloys

All component wear rates are normal.
