OIL ANALYSIS REPORT

Area
(T-21914)
Machine Id
[T-21914] 8589191201
Component
Hydraulic System
Fluid
MIL-PRF-5606H (--- GAL)

Laboratory : WearCheck - C8-1175 Appleby Line, Burlington, ON L7L 5H9 **SKYSERVICE BUSINESS AVIATION INC**
Sample No. : WC0833068 **Recieved** : 17 Jan 2024
Lab Number : 02609300 **Diagnosed** : 23 Jan 2024
Unique Number : 5710386 **Diagnostician** : Kevin Marson
Test Package : AVI 3 (Additional Tests: PrtCount)

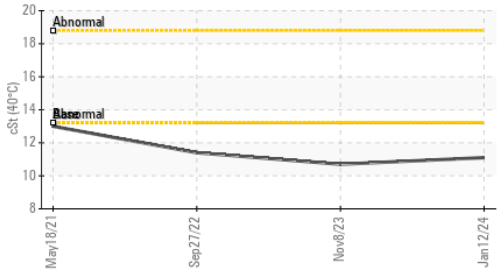
Viscosity @ 40°C

Viscosity of sample indicates oil is within ISO 10 range, advise investigate. The AN level is acceptable for this fluid. The condition of the oil is suitable for further service.

FLUID PROPERTIES		method	limit/base	current	history1	history2
Visc @ 40°C	cSt	ASTM D7279(m)	13.2	▲ **11.1**	▲ 10.7	▲ 11.4

Resample at the next service interval to monitor. NOTE: Please provide information regarding reservoir capacity, filter type and micron rating with next sample.

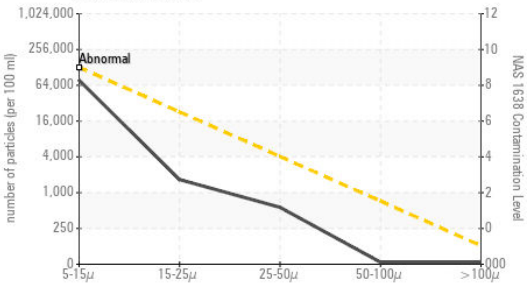
Particle Count

There is no indication of any contamination in the oil. The system and fluid cleanliness is acceptable.

FLUID CLEANLINESS		method	limit/base	current	history1	history2
Particles 5-15µm	count	NAS 1638	>128000	**77779**	73765	42140
Particles 15-25µm	count	NAS 1638	>22800	**1660**	2282	2253
Particles 25-50µm	count	NAS 1638	>4050	**567**	510	1000
Particles 50-100µm	count	NAS 1638	>720	**14**	0	114
Particles >100µm	count	NAS 1638	>128	**13**	75	33
NAS 1638	Class	NAS 1638	>9	**9**	9	8

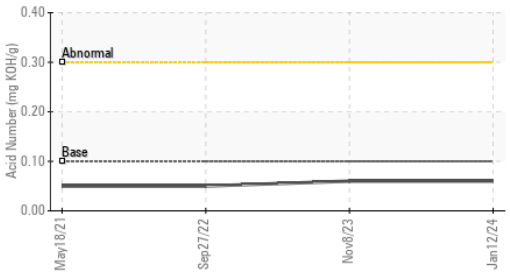
FLUID DEGRADATION		method	limit/base	current	history1	history2
Acid Number (AN)	mg KOH/g	ASTM D974*	0.1	**0.06**	0.06	0.05

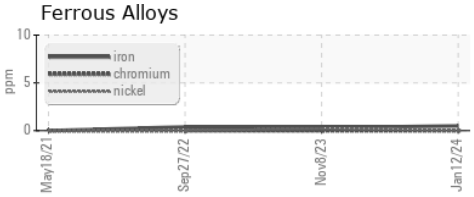
Ferrous Alloys

All component wear rates are normal. The ferrography results are normal indicating no abnormal wear in the system.

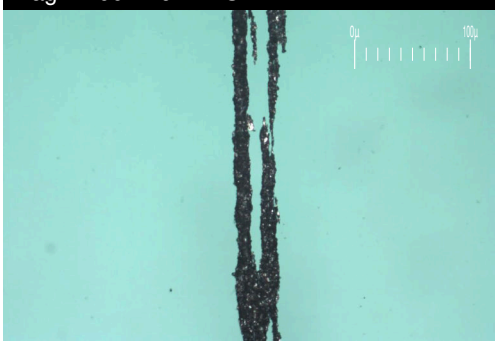
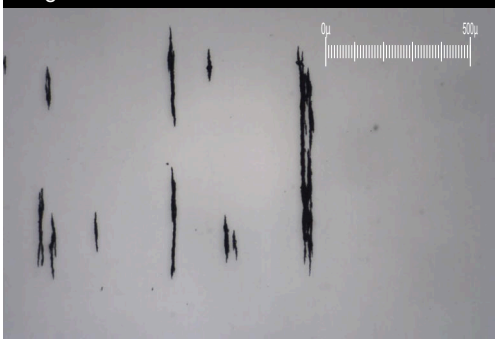
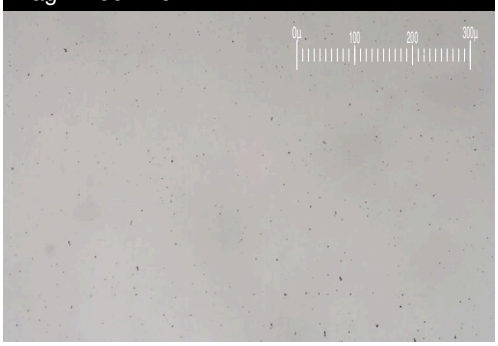
All component wear rates are normal. The ferrography results are normal indicating no abnormal wear in the system.
