Area
BRUCE B/8/43230
Machine Id
8-43230-P4-P IB Brg Drn
Component
Inboard Bearing
Fluid
ESSO NUTO H ISO 46 (--- GAL)

Customer Id: BRUTIV
Sample No.: WC0845406
Lab Number: 02609392
Test Package: IND 2

OIL ANALYSIS REPORT

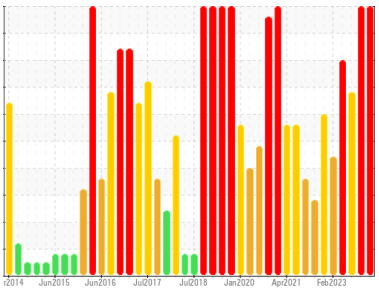
Sample Rating Trend

Sample Status				**SEVERE**	SEVERE	SEVERE
Copper	ppm	ASTM D5185(m)	>5	**13**	57	5
Ferrous Cutting	Scale 0-10	ASTM D7684*		**1**	1	1
Particles >4µm		ASTM D7647	>5000	**141054**	169532	97733
Particles >6µm		ASTM D7647	>1300	**66351**	123574	18240
Particles >14µm		ASTM D7647	>320	**959**	9288	279
Oil Cleanliness		ISO 4406 (c)	>19/17/15	**24/23/17**	25/24/20	24/21/15
PrtFilter					*no image*	*no image*

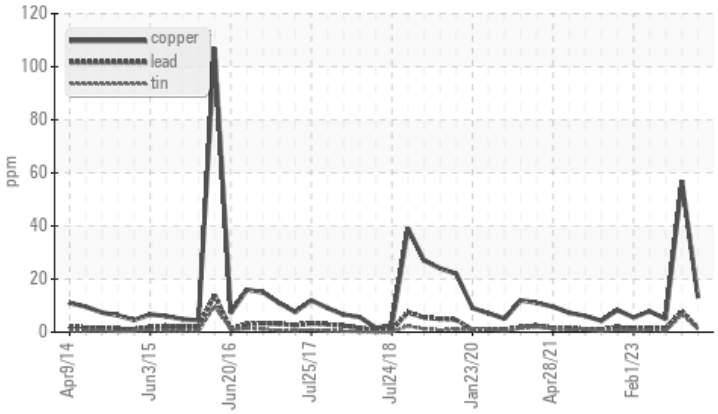
Non-ferrous Metals

Copper ppm levels are severe. Wear particle analysis indicates that the ferrous cutting particles are marginal. Bearing wear is indicated. Cutting wear particles are caused by either hard protuberances (mis-aligned components, etc.), or abrasives entering the system and embedding themselves in softer materials (sand, etc.), and gouging out mating surfaces.

Check seals and/or filters for points of contaminant entry. The air breather requires service. If unrated, we recommend that you replace with a suitable micron rated and/or desiccant air breather. If rated, we recommend that you service/replace the breather. We recommend you service the filters on this component. Resample in 30-45 days to monitor this situation. No other corrective action is recommended at this time. NOTE: Please provide information regarding reservoir capacity, filter type and micron rating with next sample.

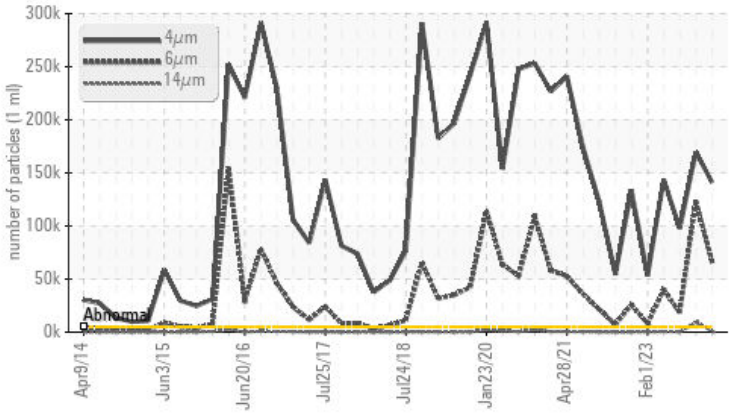
Particle Trend

There is a high amount of silt (particulates < 14 microns in size) present in the oil. The water content is negligible. The system cleanliness code is much higher than the acceptable limit for the target ISO 4406 cleanliness code.

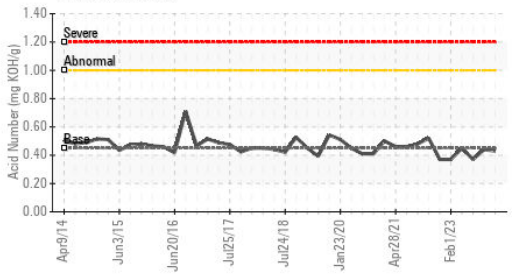
Acid Number

The AN level is acceptable for this fluid. The oil is no longer serviceable as a result of the abnormal and/or severe wear.

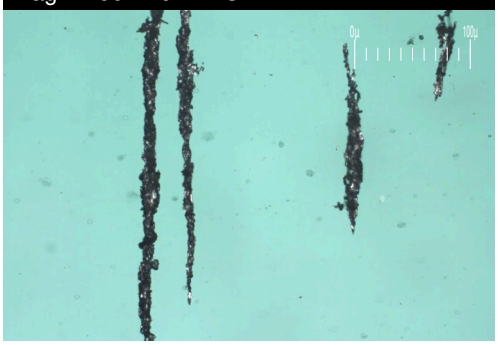
Magn: 200x Illum: BC

Copper ppm levels are severe. Wear particle analysis indicates that the ferrous cutting particles are marginal. Bearing wear is indicated. Cutting wear particles are caused by either hard protuberances (mis-aligned components, etc.), or abrasives entering the system and embedding themselves in softer materials (sand, etc.), and gouging out mating surfaces.
