OIL ANALYSIS REPORT

Area
AIM Recyclage - A14400
Machine Id
A2401076
Component
Hydraulic System
Fluid
AW HYDRAULIC OIL ISO 68 (--- LTR)

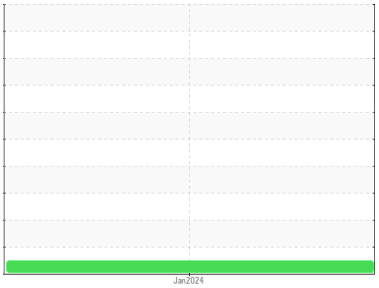
Sample Rating Trend

NORMAL

Wear
Copper and iron ppm levels are noted.

Recommendation
This is a baseline read-out on the submitted sample.

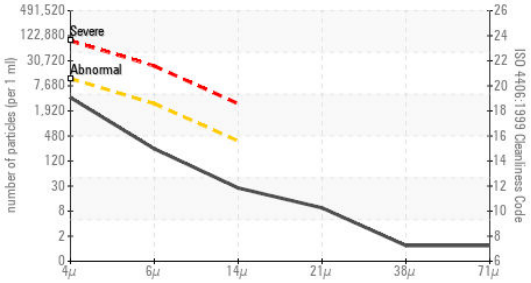
Particle Count

FLUID CLEANLINESS		method	limit/base	current	history1	history2
Particles >4µm		ASTM D7647	>10000	**3504**	---	---
Particles >6µm		ASTM D7647	>2500	**208**	---	---
Particles >14µm		ASTM D7647	>320	**24**	---	---
Particles >21µm		ASTM D7647	>80	**8**	---	---
Particles >38µm		ASTM D7647	>20	**1**	---	---
Particles >71µm		ASTM D7647	>4	**1**	---	---
Oil Cleanliness		ISO 4406 (c)	>20/18/15	**19/15/12**	---	---

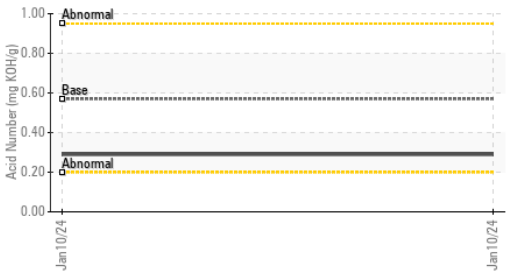
FLUID DEGRADATION		method	limit/base	current	history1	history2
Acid Number (AN)	mg KOH/g	ASTM D974*	0.57	**0.29**	---	---
