Customer Id: MUSHAP
Sample No.: WC0412138
Lab Number: 02609419
Test Package: IND 2

OIL ANALYSIS REPORT

Area
[1657852]
Machine Id
UNIT 4 TURBINE GUIDE
Component
Turbine Bearing
Fluid
PETRO CANADA TURBOFLO XL46 (900 LTR)

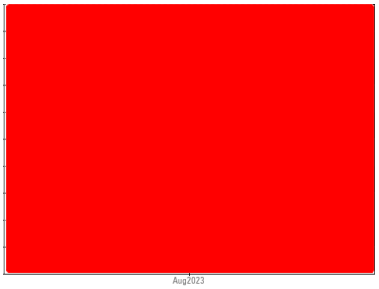
Sample Rating Trend

Sample Status				**SEVERE**	---	---
Particles >4µm		ASTM D7647	>10000	**140589**	---	---
Particles >6µm		ASTM D7647	>2500	**53651**	---	---
Particles >14µm		ASTM D7647	>160	**1598**	---	---
Particles >21µm		ASTM D7647	>40	**203**	---	---
Oil Cleanliness		ISO 4406 (c)	>20/18/14	**24/23/18**	---	---
White Metal	scalar	Visual*	NONE	**LTMOD**	---	---
Yellow Metal	scalar	Visual*	NONE	**VLITE**	---	---
PrtFilter

We advise that you check all areas where contaminants can enter the system. We advise that you check for visible metal particles in the oil. Wear particles and/or ppm levels are abnormally high indicating the need to review OEM limits with attention to components that may generate this type of wear. Include all test results and maintenance activities that have been performed since the abnormal condition was first detected in this review. We advise that you perform a filter service, and use off-line filtration to improve the cleanliness of the system fluid. The air breather requires service. If unrated, we recommend that you replace with a suitable micron rated and/or desiccant air breather. If rated, we recommend that you service/replace the breather. An inspection for the source(s) of wear may be warranted at this time. Re-sampling is suggested to confirm test results prior to significant maintenance activities being performed. Please indicate that this is a resample on your Sample Information Form (SIF). Resample in 30-45 days to monitor this situation.

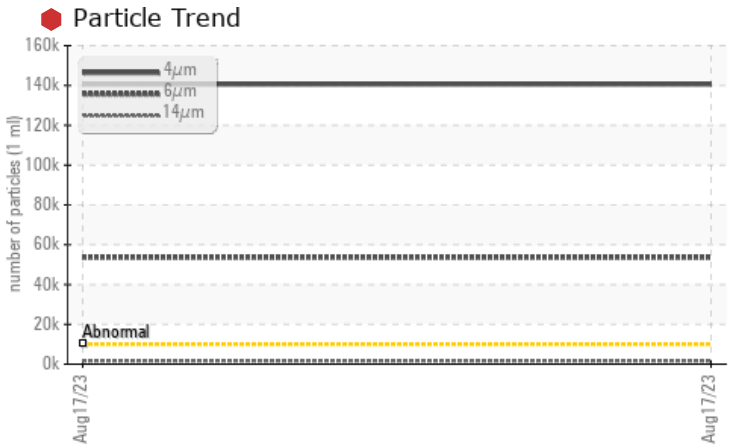
COMPONENT CONDITION SUMMARY

Moderate concentration of visible metal present. Bearing wear is indicated.

There is a high amount of particulates (2 to 100 microns in size) present in the oil.

The AN level is acceptable for this fluid. The oil is still serviceable provided that the contaminant(s) can be reduced to acceptable levels.
