Machine Id
10574168
Component
Hydraulic System
Fluid
SHELL TELLUS 68 (--- GAL)

Customer Id: INCOCOLE
Sample No.: WC0811799
Lab Number: 02609972
Test Package: IND 2

OIL ANALYSIS REPORT

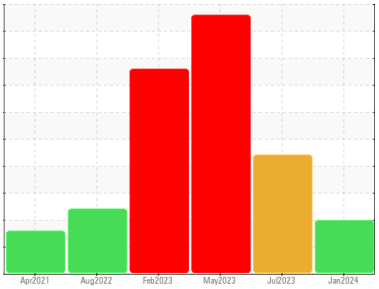
Sample Rating Trend

Sample Status				**SEVERE**	SEVERE	SEVERE
Particles >4µm		ASTM D7647	>5000	**83068**	75446	94165
Particles >6µm		ASTM D7647	>1300	**9178**	10947	32006
Oil Cleanliness		ISO 4406 (c)	>19/17/14	**24/20/14**	23/21/15	24/22/18

Check seals and/or filters for points of contaminant entry. The air breather requires service. If unrated, we recommend that you replace with a suitable micron rated and/or desiccant air breather. If rated, we recommend that you service/replace the breather. We recommend you service the filters on this component. Resample in 30-45 days to monitor this situation. NOTE: Please provide information regarding reservoir capacity, filter type and micron rating with next sample.

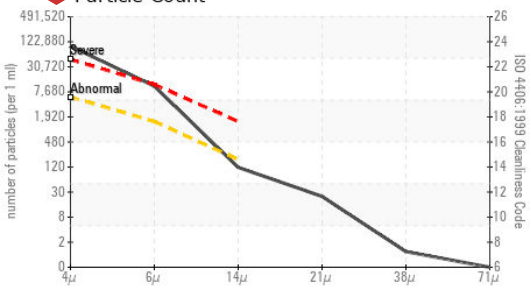
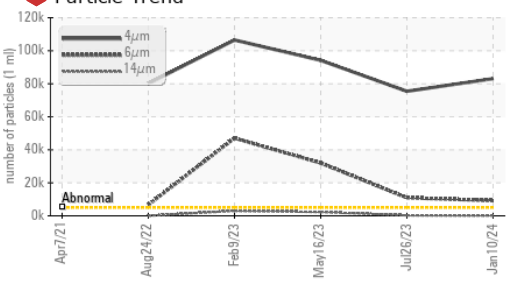
Particle Count

There is a high amount of silt (particulates < 14 microns in size) present in the oil.

FLUID CLEANLINESS		method	limit/base	current	history1	history2
Particles >4µm		ASTM D7647	>5000	**83068**	75446	94165
Particles >6µm		ASTM D7647	>1300	**9178**	10947	32006
Particles >14µm		ASTM D7647	>160	**104**	270	2300
Particles >21µm		ASTM D7647	>40	**21**	59	544
Particles >38µm		ASTM D7647	>10	**1**	1	9
Particles >71µm		ASTM D7647	>3	**0**	0	1
Oil Cleanliness		ISO 4406 (c)	>19/17/14	**24/20/14**	23/21/15	24/22/18

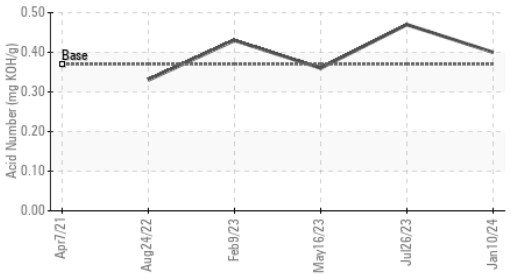
The AN level is acceptable for this fluid. The oil is still serviceable provided that the contaminant(s) can be reduced to acceptable levels.

FLUID DEGRADATION		method	limit/base	current	history1	history2
Acid Number (AN)	mg KOH/g	ASTM D974*	0.37	**0.40**	0.47	0.36
