OIL ANALYSIS REPORT

Area
Direct Strip Mill/Finishing
Machine Id
HSM WEST GLYCOL BLK (S/N DSC 196)
Component
Hydraulic System
Fluid
HOUGHTON HOUGHTON SAFE 616 (--- GAL)

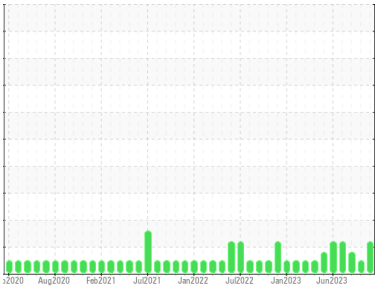
Sample Rating Trend

DEGRADATION

Due to the low reserve alkalinity it is advised that you contact HOUGHTON to assist in restoring the proper amine concentration. We recommend an early resample to monitor this condition. NOTE: Please provide information regarding reservoir capacity, filter type and micron rating with next sample.

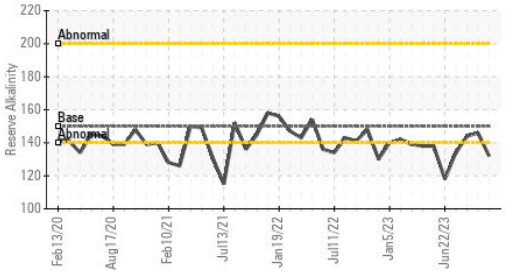
Reserve Alkalinity

The reserve alkalinity of this fluid is lower than acceptable. The AN level is acceptable for this fluid. The pH level of this fluid is within the acceptable limits. The water concentration level is acceptable for this fluid.

FLUID DEGRADATION		method	limit/base	current	history1	history2
Acid Number (AN)	mg KOH/g	ASTM D974*		**4.48**	4.44	4.72
Alkiline Reserve (Oils)	ml KOH/g	ASTM D1121*	150	▲ **132**	146	144

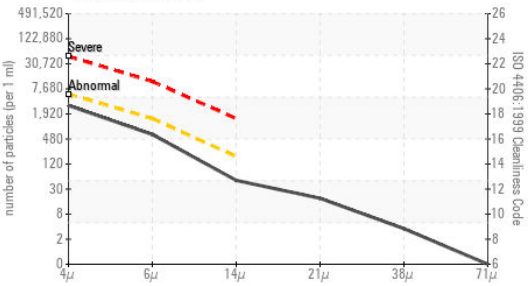
Particle Count

The system cleanliness is acceptable for your target ISO 4406 cleanliness code. The system and fluid cleanliness is acceptable.
