Area
BRUCE B/6/43230
Machine Id
6-43230-P4-P IB Brg Drn
Component
Inboard Bearing
Fluid
ESSO NUTO H ISO 46 (--- GAL)

Customer Id: BRUTIV
Sample No.: WC0845394
Lab Number: 02610569
Test Package: IND 2

OIL ANALYSIS REPORT

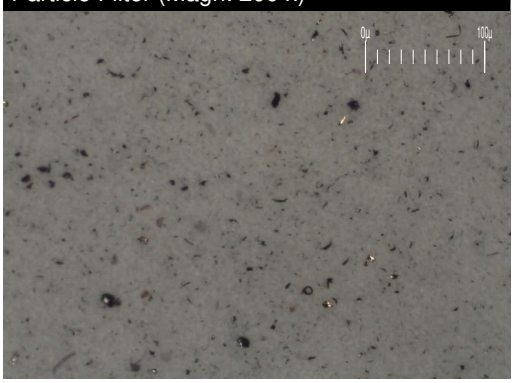
Particle Filter (Magn: 200 x)

There is a high amount of silt (particulates < 14 microns in size) present in the oil. Elemental level of silicon (Si) above normal indicating ingress of seal material. The system cleanliness code is much higher than the acceptable limit for the target ISO 4406 cleanliness code.

Check seals and/or filters for points of contaminant entry. The air breather requires service. If unrated, we recommend that you replace with a suitable micron rated and/or desiccant air breather. If rated, we recommend that you service/replace the breather. We advise that you perform a filter service, and use off-line filtration to improve the cleanliness of the system fluid. Resample in 30-45 days to monitor this situation. NOTE: Please provide information regarding reservoir capacity, filter type and micron rating with next sample.

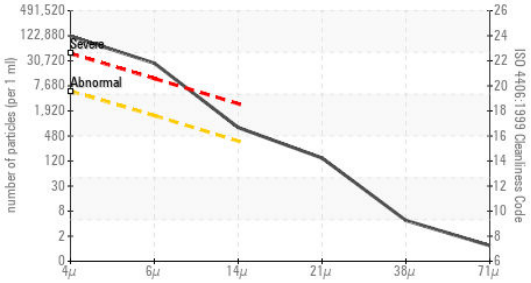
Particle Count

FLUID CLEANLINESS		method	limit/base	current	history1	history2
Particles >4µm		ASTM D7647	>5000	**102908**	109647	178919
Particles >6µm		ASTM D7647	>1300	**23388**	25331	48296
Particles >14µm		ASTM D7647	>320	▲ **672**	▲ 725	320
Particles >21µm		ASTM D7647	>80	▲ **125**	▲ 118	21
Particles >38µm		ASTM D7647	>20	**4**	2	1
Particles >71µm		ASTM D7647	>4	**1**	0	0
Oil Cleanliness		ISO 4406 (c)	>19/17/15	**24/22/17**	24/22/17	25/23/15

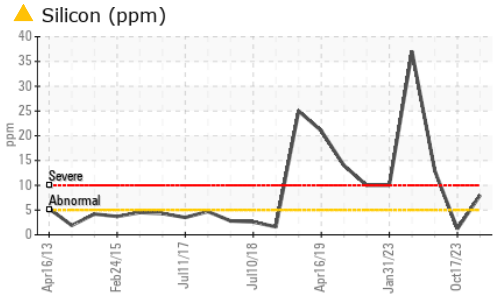
Silicon (ppm)

CONTAMINANTS		method	limit/base	current	history1	history2
Silicon	ppm	ASTM D5185(m)	>5	▲ **8**	1	13
Sodium	ppm	ASTM D5185(m)	>5	**0**	0	0
Potassium	ppm	ASTM D5185(m)	>20	**<1**	0	0
Water	%	ASTM D6304*	>0.005	**0.001**	0.001	0.001
ppm Water	ppm	ASTM D6304*	>50	**7**	14.5	3.0

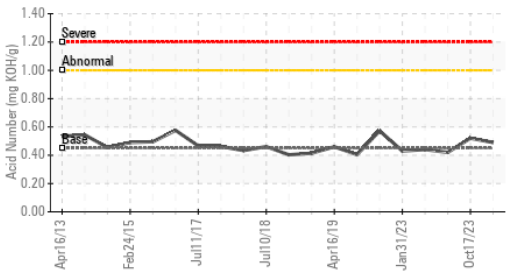
Acid Number

The AN level is acceptable for this fluid. The oil is still serviceable provided that the contaminant(s) can be reduced to acceptable levels.

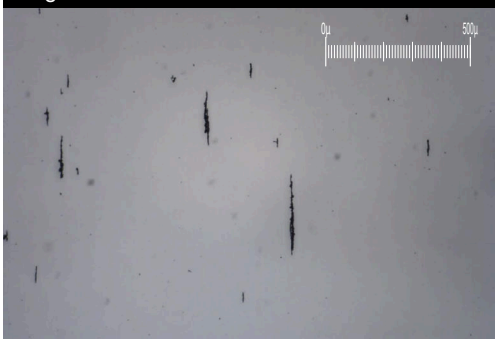
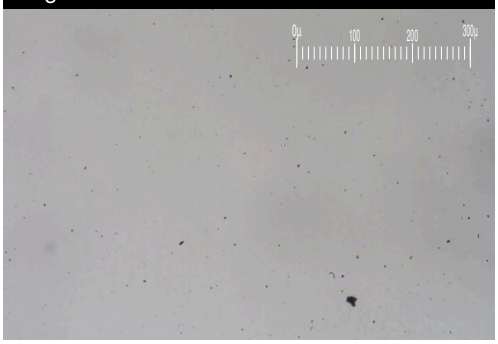
All component wear rates are normal. The ferrography results are normal indicating no abnormal wear in the system.
