Area
Formedge - F04100
Machine Id
AM994
Component
Unknown Component
Fluid
EXTRUGLISS B268 (--- GAL)

Customer Id: CHECOB
Sample No.: E30001518
Lab Number: 02620949
Test Package: IND 2

OIL ANALYSIS REPORT

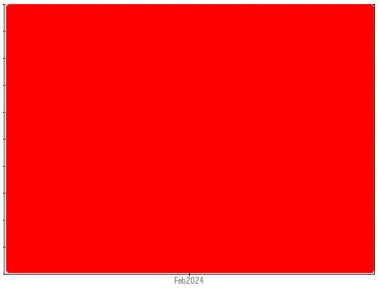
Sample Rating Trend

The sample submitted is 64 times dirtier than the ISO dirt count recommendation of 19/16/14. The total Acid Number (TAN) is higher than the recommended level of 2.0

Sample Status				**SEVERE**	---	---
Particles >4µm		ASTM D7647	>5000	▲ **273270**	---	---
Particles >6µm		ASTM D7647	>640	▲ **157172**	---	---
Particles >14µm		ASTM D7647	>160	▲ **7421**	---	---
Particles >21µm		ASTM D7647	>40	▲ **733**	---	---
Oil Cleanliness		ISO 4406 (c)	>19/16/14	▲ **25/24/20**	---	---
Acid Number (AN)	mg KOH/g	ASTM D974*		▲ **3.45**	---	---

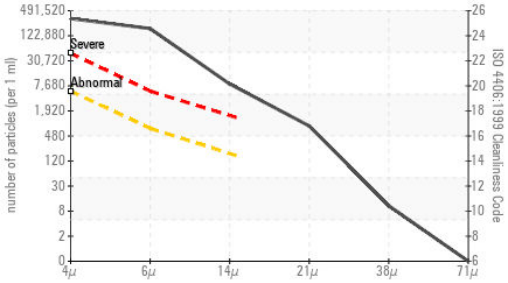
Particle Count

Contamination
Oil Cleanliness are abnormally high. Particles >14µm are abnormally high. Particles >21µm are abnormally high. Particles >4µm are abnormally high. Particles >6µm are abnormally high.

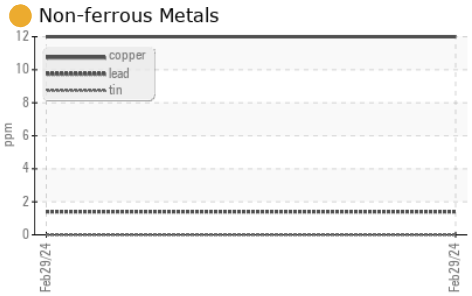
Non-ferrous Metals

Wear
Copper and iron ppm levels are noted.
