Area
Formedge - F04100
Machine Id
AM995
Component
Unknown Component
Fluid
EXTRUGLISS B268 (--- GAL)

Customer Id: CHECOB
Sample No.: E30001519
Lab Number: 02620950
Test Package: IND 2

OIL ANALYSIS REPORT

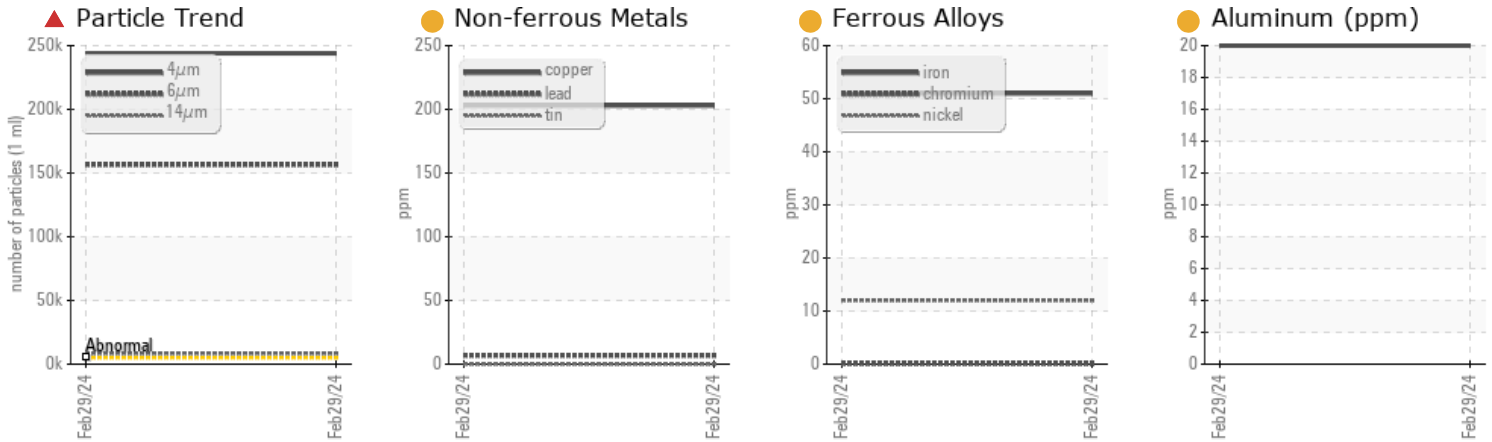
COMPONENT CONDITION SUMMARY

The sample submitted is 64 times dirtier than the ISO dirt count recommendation of 19/16/14.

Sample Status				SEVERE	---	---
Particles >4µm		ASTM D7647	>5000	▲ **243949**	---	---
Particles >6µm		ASTM D7647	>640	▲ **156627**	---	---
Particles >14µm		ASTM D7647	>160	▲ **8347**	---	---
Particles >21µm		ASTM D7647	>40	▲ **736**	---	---
Oil Cleanliness		ISO 4406 (c)	>19/16/14	▲ **25/24/20**	---	---

Contamination
Oil Cleanliness are abnormally high. Particles >14µm are abnormally high. Particles >21µm are abnormally high. Particles >4µm are abnormally high. Particles >6µm are abnormally high.

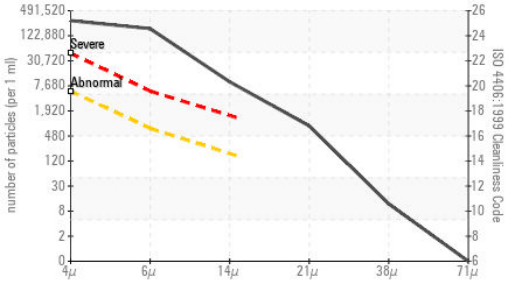
Particle Count

FLUID CLEANLINESS		method	limit/base	current	history1	history2
Particles >4µm		ASTM D7647	>5000	▲ **243949**	---	---
Particles >6µm		ASTM D7647	>640	▲ **156627**	---	---
Particles >14µm		ASTM D7647	>160	▲ **8347**	---	---
Particles >21µm		ASTM D7647	>40	▲ **736**	---	---
Particles >38µm		ASTM D7647	>10	**10**	---	---
Particles >71µm		ASTM D7647	>3	**0**	---	---
Oil Cleanliness		ISO 4406 (c)	>19/16/14	▲ **25/24/20**	---	---

Recommendation
The sample submitted is 64 times dirtier than the ISO dirt count recommendation of 19/16/14.

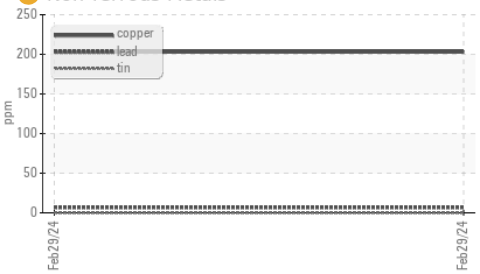
Non-ferrous Metals

Wear
Aluminum, copper, iron and nickel ppm levels are noted.
