PROBLEM SUMMARY

Area
CMI - C13620
Machine Id
A2403080
Component
Hydraulic System
Fluid
AW HYDRAULIC OIL ISO 46 (--- GAL)

OIL ANALYSIS REPORT

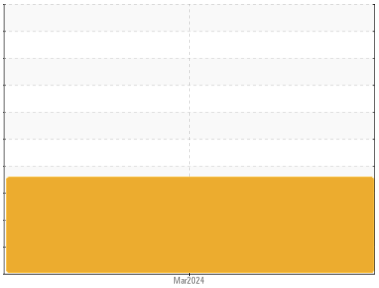
Sample Rating Trend

Sample Status				**SEVERE**	---	---
Particles >4µm		ASTM D7647	>5000	▲ **30327**	---	---
Particles >6µm		ASTM D7647	>640	▲ **7711**	---	---
Particles >14µm		ASTM D7647	>160	▲ **323**	---	---
Oil Cleanliness		ISO 4406 (c)	>19/16/14	▲ **22/20/16**	---	---

The sample submitted is 8 times dirtier than the ISO dirt count recommendation of 19/16/14.

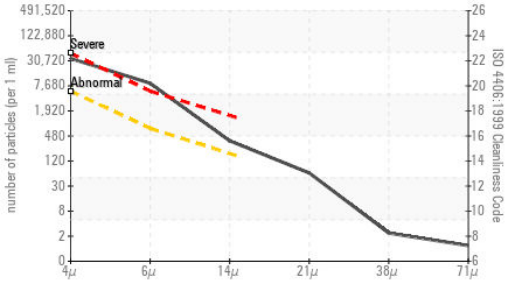
Particle Count

Contamination
Oil Cleanliness are abnormally high. Particles >4µm are abnormally high. Particles >6µm are abnormally high. Particles >14µm are notably high.

FLUID CLEANLINESS		method	limit/base	current	history1	history2
Particles >4µm		ASTM D7647	>5000	▲ **30327**	---	---
Particles >6µm		ASTM D7647	>640	▲ **7711**	---	---
Particles >14µm		ASTM D7647	>160	▲ **323**	---	---
Particles >21µm		ASTM D7647	>40	**55**	---	---
Particles >38µm		ASTM D7647	>10	**2**	---	---
Particles >71µm		ASTM D7647	>3	**1**	---	---
Oil Cleanliness		ISO 4406 (c)	>19/16/14	▲ **22/20/16**	---	---

Recommendation
The sample submitted is 8 times dirtier than the ISO dirt count recommendation of 19/16/14.

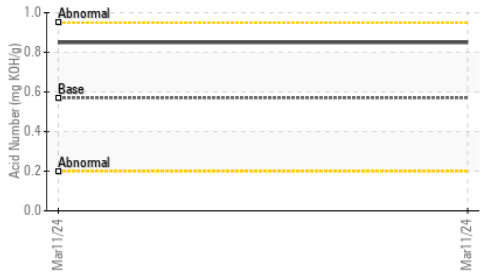
FLUID DEGRADATION		method	limit/base	current	history1	history2
Acid Number (AN)	mg KOH/g	ASTM D974*	0.57	**0.85**	---	---
