Area
Hydraulic System in Plant [413350710]
Machine Id
Hock Cutter #5 - Maximo #6144 (S/N 1000029280)
Component
Hydraulic System
Fluid
KEYSTONE NEVASTANE AW ISO 46 (10 GAL)

Customer Id: CARGUE
Sample No.: WC0918449
Lab Number: 02622001
Test Package: IND 2

OIL ANALYSIS REPORT

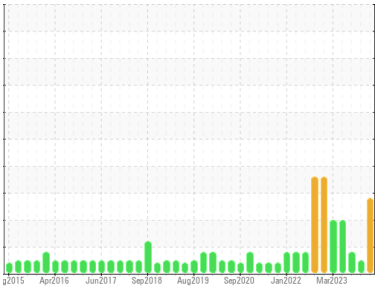
Sample Rating Trend

Sample Status				SEVERE	NORMAL	ABNORMAL
Particles >4µm		ASTM D7647	>5000	▲ **41347**	2243	▲ 16163
Particles >6µm		ASTM D7647	>1300	▲ **9097**	489	302
Particles >14µm		ASTM D7647	>160	▲ **557**	37	10
Particles >21µm		ASTM D7647	>40	▲ **137**	9	3
Oil Cleanliness		ISO 4406 (c)	>19/17/14	▲ **23/20/16**	18/16/12	▲ 21/15/10

We advise that you check all areas where contaminants can enter the system. We advise that you perform a filter service, and use off-line filtration to improve the cleanliness of the system fluid. The air breather requires service. If unrated, we recommend that you replace with a suitable micron rated and/or desiccant air breather. If rated, we recommend that you service/replace the breather. Resample in 30-45 days to monitor this situation.

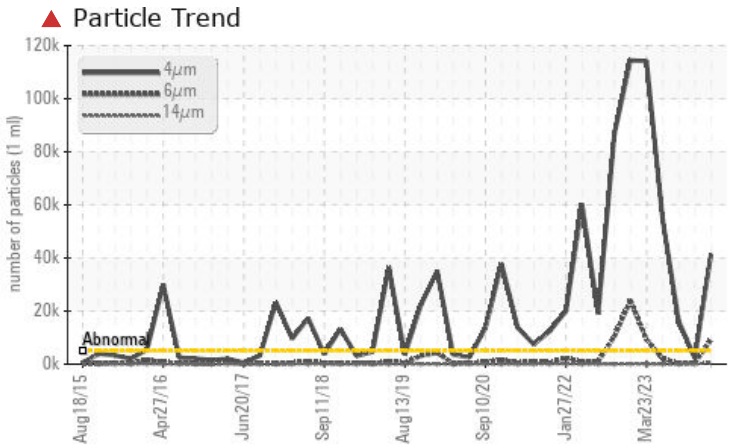
COMPONENT CONDITION SUMMARY

There is a high amount of particulates (2 to 100 microns in size) present in the oil.

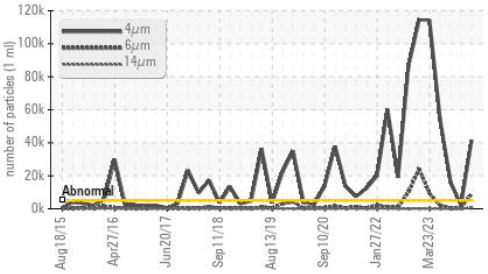
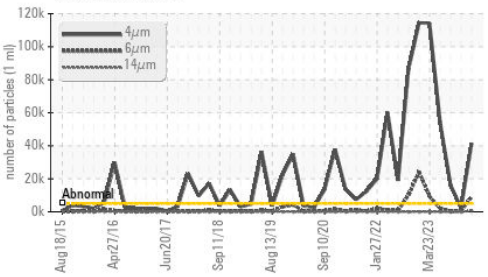
Particle Trend

FLUID CLEANLINESS		method	limit/base	current	history1	history2
Particles >4µm		ASTM D7647	>5000	▲ **41347**	2243	▲ 16163
Particles >6µm		ASTM D7647	>1300	▲ **9097**	489	302
Particles >14µm		ASTM D7647	>160	▲ **557**	37	10
Particles >21µm		ASTM D7647	>40	▲ **137**	9	3
Particles >38µm		ASTM D7647	>10	**11**	1	1
Particles >71µm		ASTM D7647	>3	**0**	0	0
Oil Cleanliness		ISO 4406 (c)	>19/17/14	▲ **23/20/16**	18/16/12	▲ 21/15/10

We advise that you check all areas where contaminants can enter the system. We advise that you perform a filter service, and use off-line filtration to improve the cleanliness of the system fluid. The air breather requires service. If unrated, we recommend that you replace with a suitable micron rated and/or desiccant air breather. If rated, we recommend that you service/replace the breather. Resample in 30-45 days to monitor this situation.

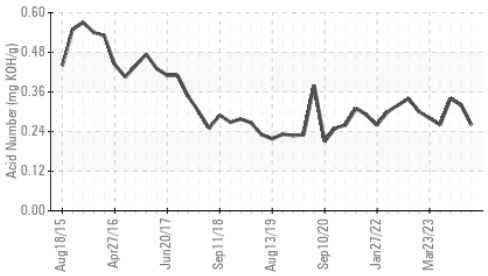
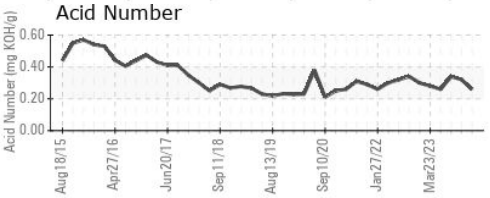
The AN level is acceptable for this fluid. The oil is still serviceable provided that the contaminant(s) can be reduced to acceptable levels.

FLUID DEGRADATION		method	limit/base	current	history1	history2
Acid Number (AN)	mg KOH/g	ASTM D974*		**0.26**	0.32	0.34

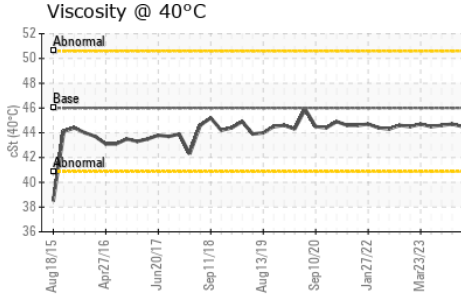
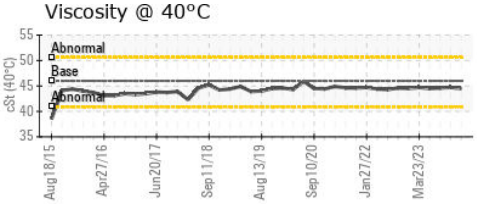
Viscosity @ 40°C

FLUID PROPERTIES		method	limit/base	current	history1	history2
Visc @ 40°C	cSt	ASTM D7279(m)	46	**44.5**	44.7	44.6
