PROBLEM SUMMARY

Area
62 BOILER FEEDWATER
Machine Id
#5 Feedwater Pump NDE (S/N 622124)
Component
Non-Drive End Pump Motor
Fluid
ESSO NUTO H ISO32 (4 LTR)

OIL ANALYSIS REPORT

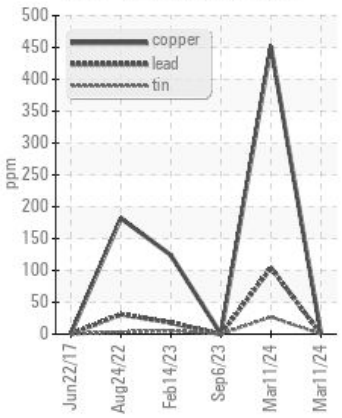
Non-ferrous Metals

▲ Wear
Copper, lead and tin ppm levels are severe. Aluminum and nickel ppm levels are abnormal. Bearing wear is indicated.

We recommend that you drain the oil from the component if this has not already been done. We recommend an early resample to monitor this condition.

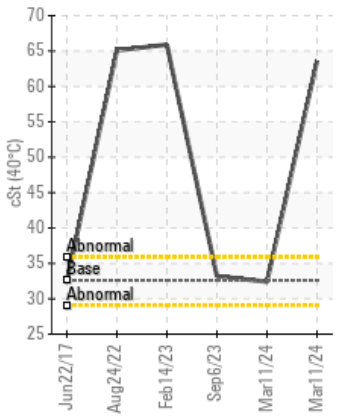
Viscosity @ 40°C

▲ Fluid Condition
Viscosity of sample indicates oil is within ISO 68 range, advise investigate. The AN level is acceptable for this fluid. The oil is no longer serviceable as a result of the abnormal and/or severe wear.
