OIL ANALYSIS REPORT

Area
Appleton
Machine Id
PARKER AP-G2-HPU
Component
Hydraulic System
Fluid
SHELL TELLUS S2 MX 32 (30 LTR)

SAMPLE INFORMATION		method	limit/base	current	history1	history2
Sample Number		Client Info		**WC0908335**	---	---
Sample Date		Client Info		**13 Mar 2024**	---	---
Machine Age		Client Info		**0**	---	---
Oil Age		Client Info		**2**	---	---
Oil Changed		Client Info		**Not Changd**	---	---
Sample Status				**ABNORMAL**	---	---

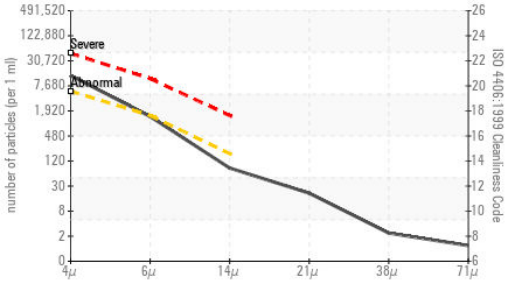
Particle Count

Contaminants
There is a moderate amount of silt (particulates < 14 microns in size) present in the oil.

FLUID CLEANLINESS		method	limit/base	current	history1	history2
Particles >4µm		ASTM D7647	>5000	▲ **11877**	---	---
Particles >6µm		ASTM D7647	>1300	**1233**	---	---
Particles >14µm		ASTM D7647	>160	**72**	---	---
Particles >21µm		ASTM D7647	>40	**18**	---	---
Particles >38µm		ASTM D7647	>10	**2**	---	---
Particles >71µm		ASTM D7647	>3	**1**	---	---
Oil Cleanliness		ISO 4406 (c)	>19/17/14	▲ **21/17/13**	---	---

Recommendation
We recommend you service the filters on this component. We recommend an early resample to monitor this condition.

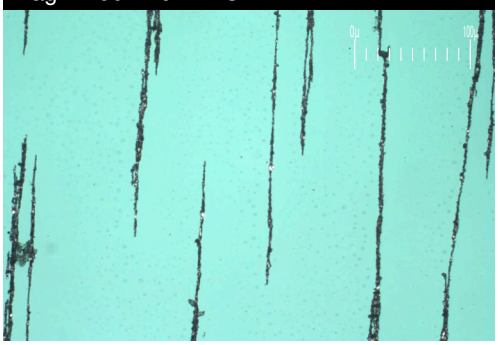
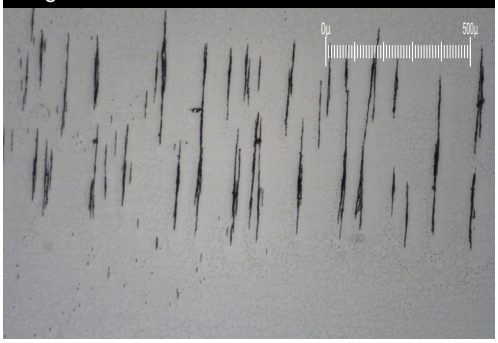
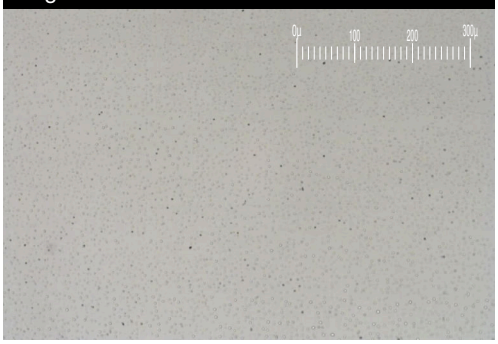
All component wear rates are normal. The ferrography results are normal indicating no abnormal wear in the system.
