Customer Id: GEPCOB
Sample No.: WC0839729
Lab Number: 02622847
Test Package: IND 2

OIL ANALYSIS REPORT

Area
[9302476288]
Machine Id
007-10011-1 WEST AERATION BLOWER NON DRIVE END
Component
Non-Drive End Blower
Fluid
PETRO CANADA SYNDURO SHB ISO150 (--- GAL)

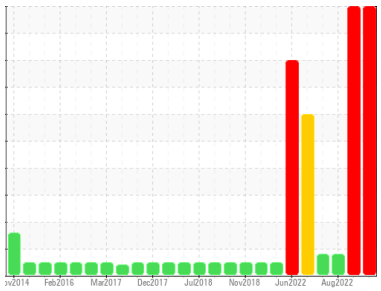
Sample Rating Trend

WEAR

Iron ppm levels are severe. PQ levels are severe. The very high ferrous density (PQ) index indicates that severe wear is occurring.

We recommend that you drain the oil from the component if this has not already been done. Confirm the source of the lubricant being utilized for top-up/fill. We recommend an early resample to monitor this condition. NOTE: Please provide information regarding reservoir capacity, filter type and micron rating with next sample.

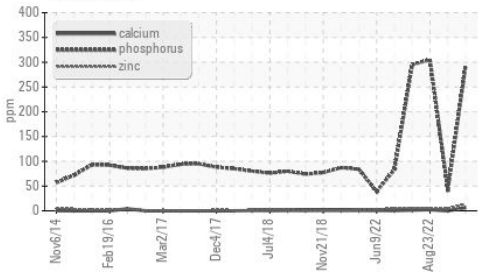
Additives

Viscosity of sample indicates oil is within ISO 220 range, advise investigate. This plus the additive levels indicates that this is not the same brand, or type of oil as reported. The AN level is acceptable for this fluid. The oil is no longer serviceable as a result of the abnormal and/or severe wear.
