Area
BRUCE B/0B/54600
Machine Id
0B-54600-SG8-TK2 Pwr Turbine
Component
Turbine
Fluid
MOBIL SHC 825 (--- GAL)

Customer Id: BRUTIV
Sample No.: WC0756835
Lab Number: 02623039
Test Package: AOM 3

OIL ANALYSIS REPORT

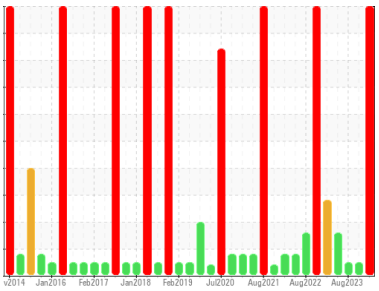
Sample Rating Trend

CONTAMINANT

Sample Status				**SEVERE**	NORMAL	NORMAL
MPC Varnish Potential	Scale	ASTM D7843(m)*	>15	**16**	---	---
Separability	oil/h2o/em	ASTM D1401*	42/38/0	**0/0/80 (30)**	---	---

We recommend an early resample to monitor this condition. No other corrective action is recommended at this time. NOTE: Please provide information regarding reservoir capacity, filter type and micron rating with next sample. Diagnostician's Note: This oil product has poor water shedding properties. Ensure that moisture levels remain low.

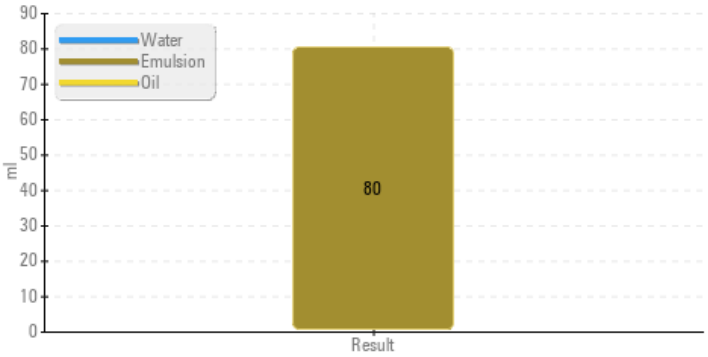
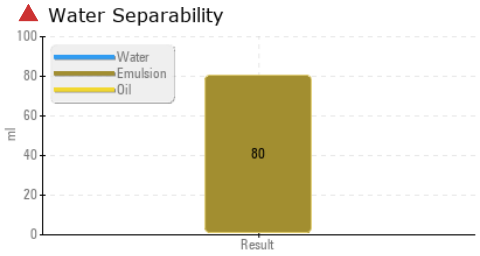
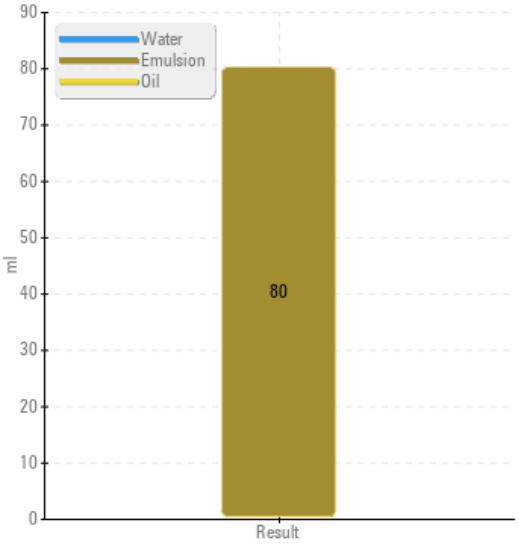
MPC (Membrane Patch Colorimetry) test indicates a light concentration of varnish present. Water Separability results (ASTM D1401) are poor and indicate that the oil will form emulsions with water. The system cleanliness is acceptable for your target ISO 4406 cleanliness code. The water content is negligible.

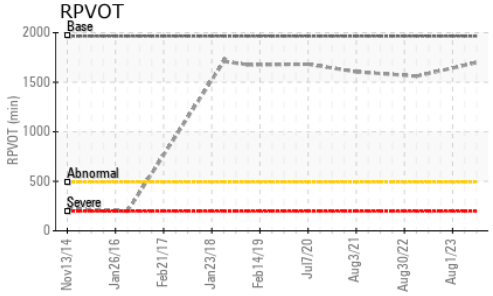
RPVOT

FLUID PROPERTIES		method	limit/base	current	history1	history2
Visc @ 40°C	cSt	ASTM D7279(m)	44	**44.3**	44.0	44.2
Visc @ 100°C	cSt	ASTM D7279(m)	7.9	**7.6**	7.6	---
Viscosity Index (VI)	Scale	ASTM D2270*	145	**139**	140	---
Separability	oil/h2o/em	ASTM D1401*	42/38/0	▲ **0/0/80 (30)**	---	---
Air Release Time	min	ASTM D3427*	4.8	**6.20**	---	---
Foam Tendency	I/II/III	ASTM D892*	25	**330/60/430**	---	---
Foam Stability	I/II/III	ASTM D892*	0	**0/0/0**	---	---
ASTM Color	scalar	ASTM D1500*	0.5	**2.0**	---	---
Rust Prevention	PASS/FAIL	ASTM D665*	PASS	**PASS**	---	---
Oxidation Test (RPVOT)	minutes	ASTM D2272*	1965	**1699**	---	---

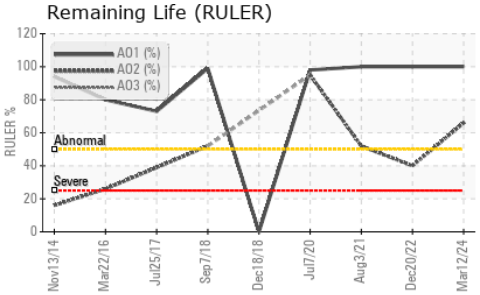
Remaining Life (RULER)

FLUID DEGRADATION		method	limit/base	current	history1	history2
Oxidation	Abs/.1mm	ASTM D7414*		**28.5**	---	---
Acid Number (AN)	mg KOH/g	ASTM D974*	0.5	**0.18**	0.14	0.15
Anti-Oxidant 1	%	ASTM D6971*	<25	**100**	---	---
Anti-Oxidant 2	%	ASTM D6971*	<25	**66**	---	---
MPC Varnish Potential	Scale	ASTM D7843(m)*	>15	▲ **16**	---	---

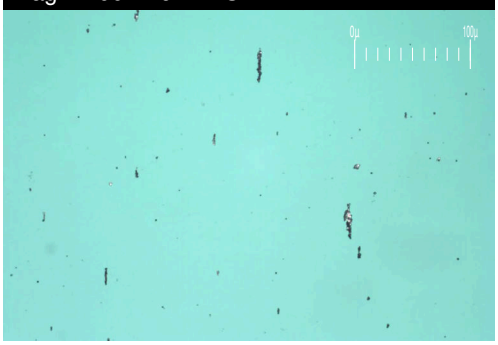
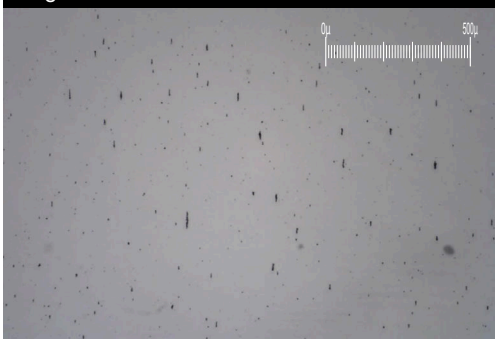
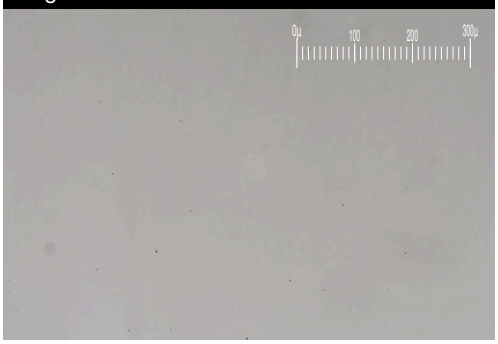
All component wear rates are normal. The ferrography results are normal indicating no abnormal wear in the system.

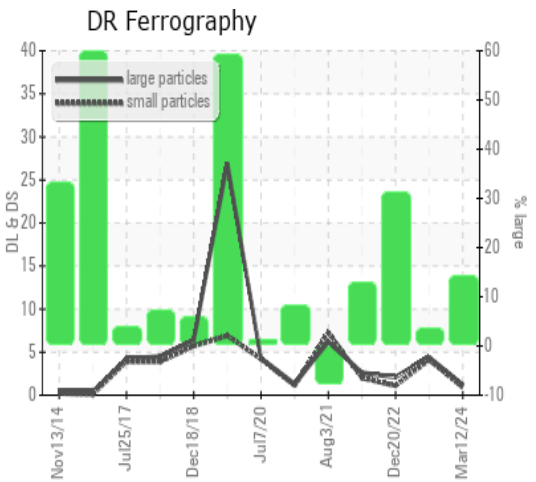
WEAR

FERROGRAPHY		method	limit/base	current	history1	history2
Ferrous Rubbing	Scale 0-10	ASTM D7684*		**2**		
Ferrous Sliding	Scale 0-10	ASTM D7684*				
Ferrous Cutting	Scale 0-10	ASTM D7684*				
Ferrous Rolling	Scale 0-10	ASTM D7684*		**1**		
Ferrous Break-in	Scale 0-10	ASTM D7684*				
Ferrous Spheres	Scale 0-10	ASTM D7684*				
Ferrous Black Oxides	Scale 0-10	ASTM D7684*				
Ferrous Red Oxides	Scale 0-10	ASTM D7684*				
Ferrous Corrosive	Scale 0-10	ASTM D7684*				
Ferrous Other	Scale 0-10	ASTM D7684*				
Nonferrous Rubbing	Scale 0-10	ASTM D7684*				
Nonferrous Sliding	Scale 0-10	ASTM D7684*				
Nonferrous Cutting	Scale 0-10	ASTM D7684*				
Nonferrous Rolling	Scale 0-10	ASTM D7684*				
Nonferrous Other	Scale 0-10	ASTM D7684*				
Carbonaceous Material	Scale 0-10	ASTM D7684*				
Lubricant Degradation	Scale 0-10	ASTM D7684*				
Sand/Dirt	Scale 0-10	ASTM D7684*		**1**		
Fibres	Scale 0-10	ASTM D7684*				
Spheres	Scale 0-10	ASTM D7684*
