PROBLEM SUMMARY

OIL ANALYSIS REPORT

Area
[804702]
Machine Id
TINKER OMEGA PH82503 TRAY STAKER (S/N MIP-1224)
Component
Hydraulic System
Fluid
CASTROL HYSPIN DHV 46 (225 LTR)

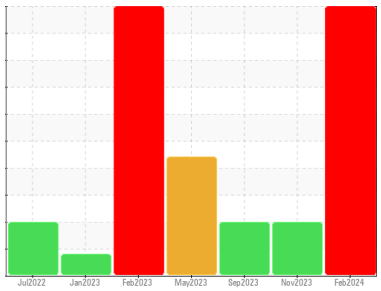
Sample Rating Trend

Sample Status				SEVERE	ABNORMAL	ABNORMAL
Particles >4µm		ASTM D7647	>5000	▲ **78371**	▲ 24869	▲ 14844
Particles >6µm		ASTM D7647	>1300	▲ **36293**	▲ 8034	▲ 4340
Particles >14µm		ASTM D7647	>160	▲ **5399**	▲ 571	▲ 341
Particles >21µm		ASTM D7647	>40	▲ **1718**	▲ 117	● 64
Particles >38µm		ASTM D7647	>10	▲ **154**	5	4
Particles >71µm		ASTM D7647	>3	▲ **7**	1	1
Oil Cleanliness		ISO 4406 (c)	>19/17/14	▲ **23/22/20**	▲ 22/20/16	▲ 21/19/16

We advise that you check all areas where contaminants can enter the system. We advise that you perform a filter service, and use off-line filtration to improve the cleanliness of the system fluid. The air breather requires service. If unrated, we recommend that you replace with a suitable micron rated and/or desiccant air breather. If rated, we recommend that you service/replace the breather. Resample in 30-45 days to monitor this situation.

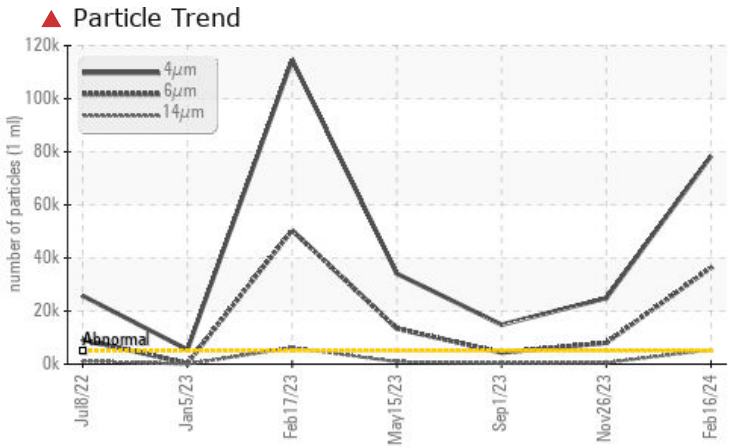
COMPONENT CONDITION SUMMARY

Wear
All component wear rates are normal.

Fluid Condition
The AN level is acceptable for this fluid. The oil is still serviceable provided that the contaminant(s) can be reduced to acceptable levels.

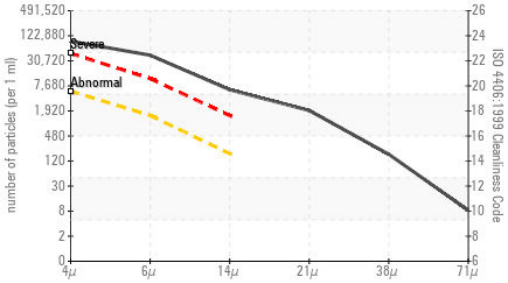
Particle Count

Contamination
There is a high amount of particulates (2 to 100 microns in size) present in the oil.

FLUID CLEANLINESS		method	limit/base	current	history1	history2
Particles >4µm		ASTM D7647	>5000	▲ **78371**	▲ 24869	▲ 14844
Particles >6µm		ASTM D7647	>1300	▲ **36293**	▲ 8034	▲ 4340
Particles >14µm		ASTM D7647	>160	▲ **5399**	▲ 571	▲ 341
Particles >21µm		ASTM D7647	>40	▲ **1718**	▲ 117	● 64
Particles >38µm		ASTM D7647	>10	▲ **154**	5	4
Particles >71µm		ASTM D7647	>3	▲ **7**	1	1
Oil Cleanliness		ISO 4406 (c)	>19/17/14	▲ **23/22/20**	▲ 22/20/16	▲ 21/19/16

Recommendation
We advise that you check all areas where contaminants can enter the system. We advise that you perform a filter service, and use off-line filtration to improve the cleanliness of the system fluid. The air breather requires service. If unrated, we recommend that you replace with a suitable micron rated and/or desiccant air breather. If rated, we recommend that you service/replace the breather. Resample in 30-45 days to monitor this situation.

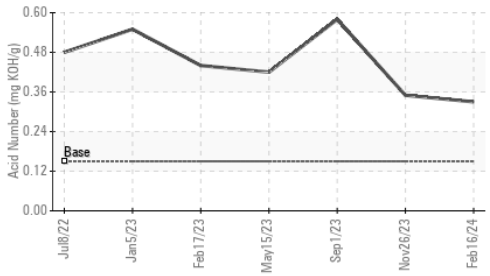
FLUID DEGRADATION		method	limit/base	current	history1	history2
Acid Number (AN)	mg KOH/g	ASTM D974*	0.15	**0.33**	0.35	0.58

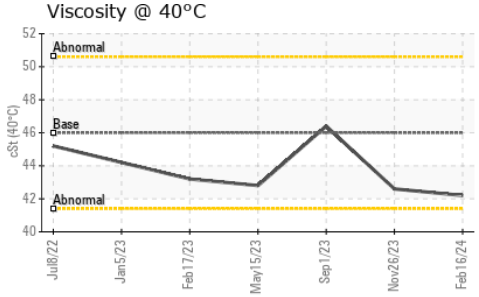
Viscosity @ 40°C

FLUID PROPERTIES		method	limit/base	current	history1	history2
Visc @ 40°C	cSt	ASTM D7279(m)	46.0	**42.2**	42.6	46.4
