OIL ANALYSIS REPORT

Area
1220 Birchmount
Machine Id
D1 NISSEI
Component
Hydraulic System
Fluid
AW HYDRAULIC OIL ISO 46 (--- GAL)

Laboratory : WearCheck - C8-1175 Appleby Line, Burlington, ON L7L 5H9
Sample No. : WC0921787
Lab Number : 02623415
Unique Number : 5748534
Test Package : IND 2

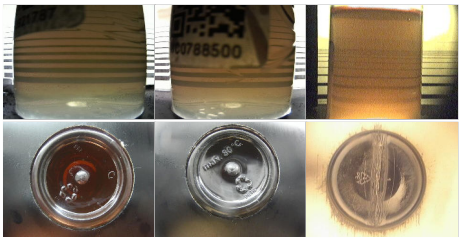
SAMPLE IMAGES	method	limit/base	current	history1	history2
Color					
Bottom

There is a light amount of silt (particulates < 14 microns in size) present in the oil.
