Customer Id: CHECOB
Sample No.: E30001720
Lab Number: 02624235
Test Package: IND 2

OIL ANALYSIS REPORT

Area
Biorigin - C11200
Machine Id
AM996
Component
Unknown Component
Fluid
MOBIL TERESSTIC 46 (--- GAL)

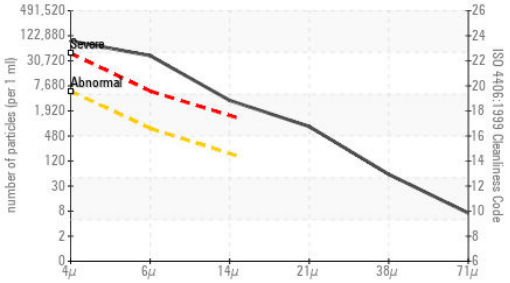
Particle Count

Contamination
Oil Cleanliness are abnormally high. Particles >14µm are abnormally high. Particles >21µm are abnormally high. Particles >6µm are abnormally high. Particles >4µm are abnormally high. Particles >38µm are abnormally high.

FLUID CLEANLINESS		method	limit/base	current	history1	history2
Particles >4µm		ASTM D7647	>5000	▲ **79320**	---	---
Particles >6µm		ASTM D7647	>640	▲ **35284**	---	---
Particles >14µm		ASTM D7647	>160	▲ **2995**	---	---
Particles >21µm		ASTM D7647	>40	▲ **711**	---	---
Particles >38µm		ASTM D7647	>10	▲ **51**	---	---
Particles >71µm		ASTM D7647	>3	▲ **6**	---	---
Oil Cleanliness		ISO 4406 (c)	>19/16/14	▲ **23/22/19**	---	---

Recommendation
The sample submitted is 16 times dirtier than the ISO dirt count recommendation of 19/16/14.

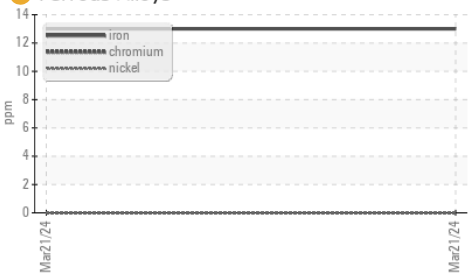
Ferrous Alloys

Wear
Iron ppm levels are noted.

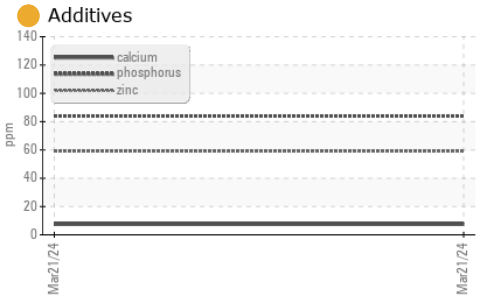
Additives

Fluid Condition
Phosphorus ppm levels are notably high. Zinc ppm levels are notably high.

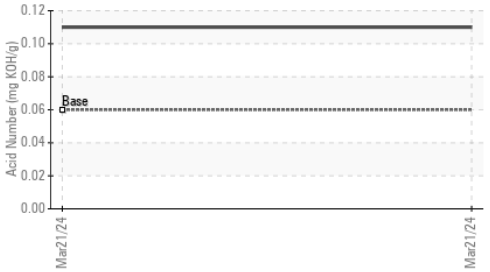
FLUID DEGRADATION		method	limit/base	current	history1	history2
Acid Number (AN)	mg KOH/g	ASTM D974*	0.06	**0.11**	---	---
