Area
Alfa Paper Products - A11300
Machine Id
AM999
Component
Hydraulic System
Fluid
AW HYDRAULIC OIL ISO 46 (--- GAL)

Customer Id: CHECOB
Sample No.: E30001723
Lab Number: 02624238
Test Package: IND 2

OIL ANALYSIS REPORT

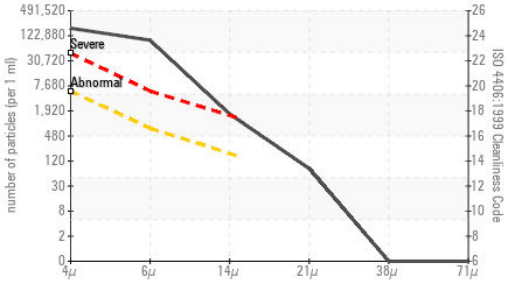
Particle Count

Contamination
Oil Cleanliness are abnormally high. Particles >4µm are abnormally high. Particles >6µm are abnormally high. Particles >14µm are abnormally high.

FLUID CLEANLINESS		method	limit/base	current	history1	history2
Particles >4µm		ASTM D7647	>5000	▲ **160129**	---	---
Particles >6µm		ASTM D7647	>640	▲ **82780**	---	---
Particles >14µm		ASTM D7647	>160	▲ **1416**	---	---
Particles >21µm		ASTM D7647	>40	● **70**	---	---
Particles >38µm		ASTM D7647	>10	**0**	---	---
Particles >71µm		ASTM D7647	>3	**0**	---	---
Oil Cleanliness		ISO 4406 (c)	>19/16/14	▲ **25/24/18**	---	---

The sample submitted is 64 times dirtier than the ISO dirt count recommendation of 19/16/14.

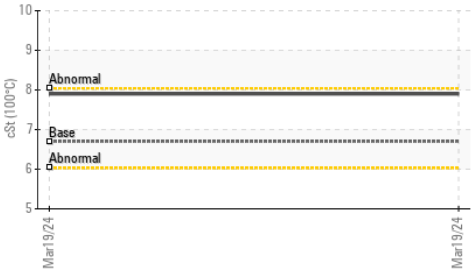
Viscosity @ 100°C

Fluid Condition
Visc @ 100°C is abnormally high. Visc @ 40°C is abnormally high.

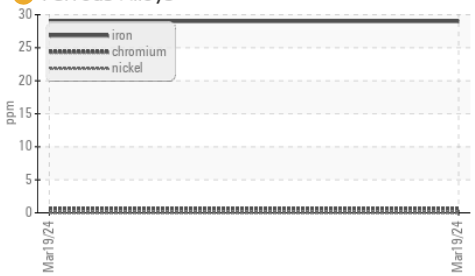
Ferrous Alloys

Wear
Iron ppm levels are noted.
