PROBLEM SUMMARY

Area
Biorigin - C11200
Machine Id
AM998
Component
Unknown Component
Fluid
CHEM-ECOL PMO 220 (--- GAL)

OIL ANALYSIS REPORT

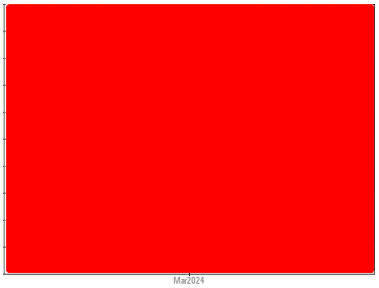
Sample Rating Trend

The sample submitted is wet and 64 times dirtier than the ISO dirt count recommendation of 19/16/14.

Sample Status				**SEVERE**	---	---
Particles >4µm		ASTM D7647	>5000	▲ **165163**	---	---
Particles >6µm		ASTM D7647	>640	▲ **86072**	---	---
Particles >14µm		ASTM D7647	>160	▲ **13043**	---	---
Particles >21µm		ASTM D7647	>40	▲ **3944**	---	---
Particles >38µm		ASTM D7647	>10	▲ **183**	---	---
Oil Cleanliness		ISO 4406 (c)	>19/16/14	▲ **25/24/21**	---	---

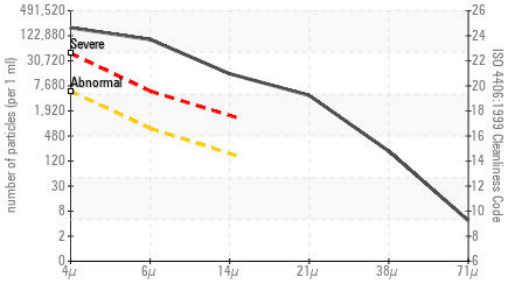
Particle Count

Contamination
Oil Cleanliness are abnormally high. Particles >14µm are abnormally high. Particles >21µm are abnormally high. Particles >4µm are abnormally high. Particles >38µm are abnormally high. Particles >6µm are abnormally high.

FLUID CLEANLINESS		method	limit/base	current	history1	history2
Particles >4µm		ASTM D7647	>5000	▲ **165163**	---	---
Particles >6µm		ASTM D7647	>640	▲ **86072**	---	---
Particles >14µm		ASTM D7647	>160	▲ **13043**	---	---
Particles >21µm		ASTM D7647	>40	▲ **3944**	---	---
Particles >38µm		ASTM D7647	>10	▲ **183**	---	---
Particles >71µm		ASTM D7647	>3	**4**	---	---
Oil Cleanliness		ISO 4406 (c)	>19/16/14	▲ **25/24/21**	---	---

Recommendation
The sample submitted is wet and 64 times dirtier than the ISO dirt count recommendation of 19/16/14.

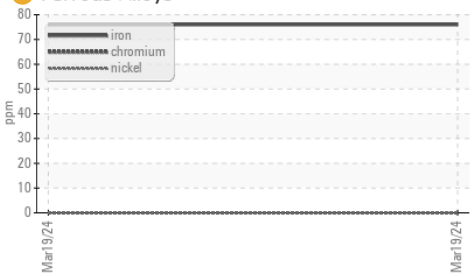
Ferrous Alloys

Wear
Iron ppm levels are noted.

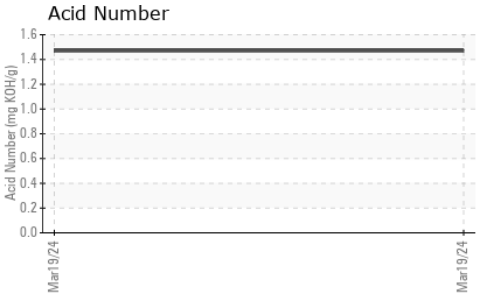
FLUID DEGRADATION		method	limit/base	current	history1	history2
Acid Number (AN)	mg KOH/g	ASTM D974*		**1.47**	---	---

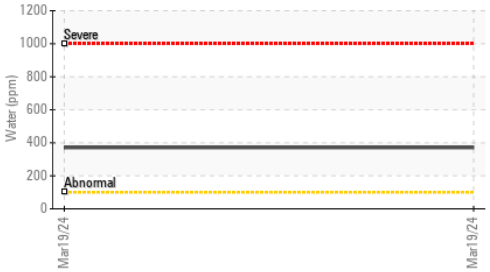
Water (KF)

CONTAMINANTS		method	limit/base	current	history1	history2
Silicon	ppm	ASTM D5185(m)		**0**	---	---
Sodium	ppm	ASTM D5185(m)		**2**	---	---
Potassium	ppm	ASTM D5185(m)	>20	**<1**	---	---
Water	%	ASTM D6304*		**0.037**	---	---
ppm Water	ppm	ASTM D6304*		**371**	---	---

VISUAL		method	limit/base	current	history1	history2
White Metal	scalar	Visual*	NONE	**NONE**	---	---
Yellow Metal	scalar	Visual*	NONE	**NONE**	---	---
Precipitate	scalar	Visual*	NONE	**NONE**	---	---
Silt	scalar	Visual*	NONE	**NONE**	---	---
Debris	scalar	Visual*	NONE	**VLITE**	---	---
Sand/Dirt	scalar	Visual*	NONE	**NONE**	---	---
Appearance	scalar	Visual*	NORML	**WGOIL**	---	---
Odor	scalar	Visual*	NORML	**NORML**	---	---
Emulsified Water	scalar	Visual*		**NEG**	---	---
Free Water	scalar	Visual*		● **>10%**	---	---
