OIL ANALYSIS REPORT

Area
ORIN CONTRACTORS
Machine Id
231
Component
Hydraulic System
Fluid
PETRO CANADA HYDREX AW 46 (--- GAL)

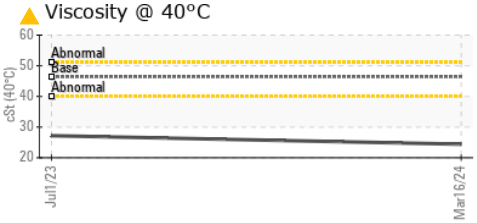
▲ Viscosity @ 40°C

Fluid Condition
Viscosity of sample indicates oil is within ISO 22 range, advise investigate. The AN level is acceptable for this fluid. The condition of the oil is suitable for further service.

FLUID PROPERTIES		method	limit/base	current	history1	history2
Visc @ 40°C	cSt	ASTM D7279(m)	46.4	▲ **24.4**	27.2	---

Recommendation
Resample at the next service interval to monitor.

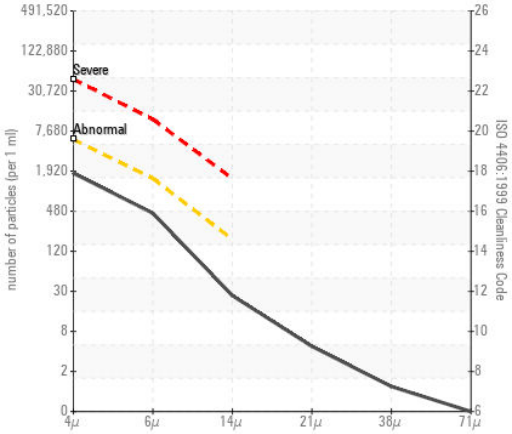
Particle Count

Contamination
The system cleanliness is acceptable for your target ISO 4406 cleanliness code. The system and fluid cleanliness is acceptable.

FLUID CLEANLINESS		method	limit/base	current	history1	history2
Particles >4µm		ASTM D7647	>5000	**1569**	4153	---
Particles >6µm		ASTM D7647	>1300	**394**	1365	---
Particles >14µm		ASTM D7647	>160	**23**	88	---
Particles >21µm		ASTM D7647	>40	**4**	13	---
Particles >38µm		ASTM D7647	>10	**1**	0	---
Particles >71µm		ASTM D7647	>3	**0**	0	---
Oil Cleanliness		ISO 4406 (c)	>19/17/14	**18/16/12**	19/18/14	---
