Machine Id
G2 L3
Component
Hydraulic System
Fluid
{not provided} (--- GAL)

Customer Id: DIO580OTT
Sample No.: ST45544
Lab Number: 02624949
Test Package: IND 2

OIL ANALYSIS REPORT

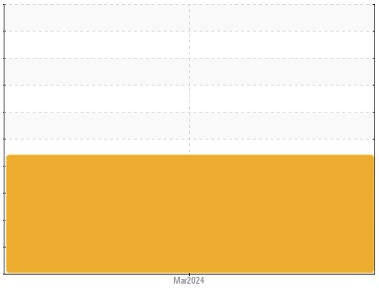
Sample Rating Trend

DEGRADATION

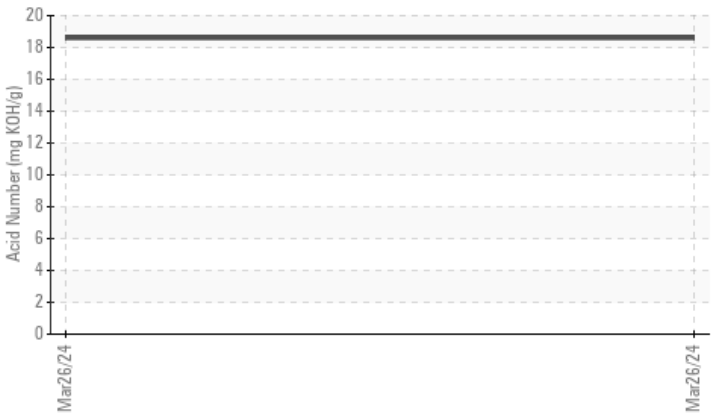
▲ Acid Number

▲ Particle Trend

Sample Status				**SEVERE**	---	---
Particles >4µm		ASTM D7647	>5000	▲ **10839**	---	---
Oil Cleanliness		ISO 4406 (c)	>19/17/14	▲ **21/18/13**	---	---
Acid Number (AN)	mg KOH/g	ASTM D974*		▲ **18.6**	---	---

Action	Status	Date	Done By	Description
Change Fluid	---	---	?	We recommend that you drain the oil from the component if this has not already been done.
Change Filter	---	---	?	We recommend you service the filters on this component.
Resample	---	---	?	We recommend an early resample to monitor this condition.
Alert	---	---	?	Little or no information is provided as to the component and lubricant being tested. Recommendations are therefore generic in nature and may not apply to the current application. Please forward information as to equipment type, reservoir capacity, lubricant type and any pertinent information to allow for a more accurate assessment.
Information Required	---	---	?	Please specify the brand, type, and viscosity of the oil on your next sample. NOTE: Please provide information regarding reservoir capacity, filter type and micron rating with next sample.
