OIL ANALYSIS REPORT

Machine Id
[C-GOHA] AS355NP C-GOHA
Component
Rotor Gearbox
Fluid
ANDEROL ROYCO 586M (6 Oz)

FERROGRAPHY REPORT

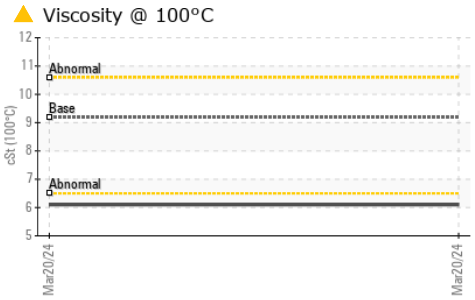
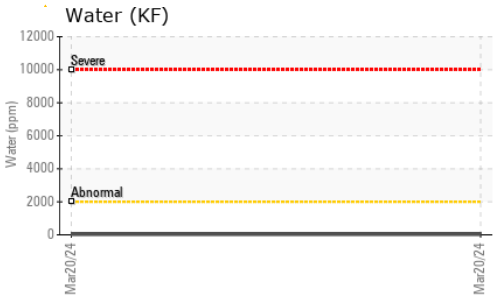
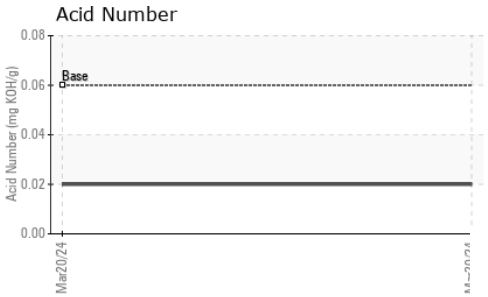
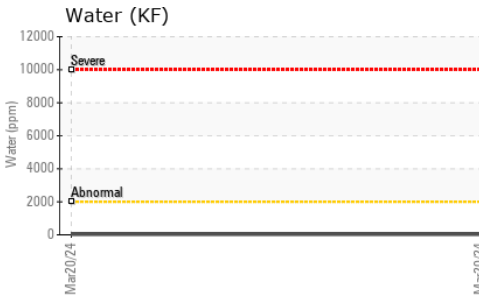
Oil Condition
The oil viscosity is lower than typical, possibly indicating the addition of lighter grade oil. The condition of the oil is acceptable for the time in service.

Recommendation
Resample at the next service interval to monitor.

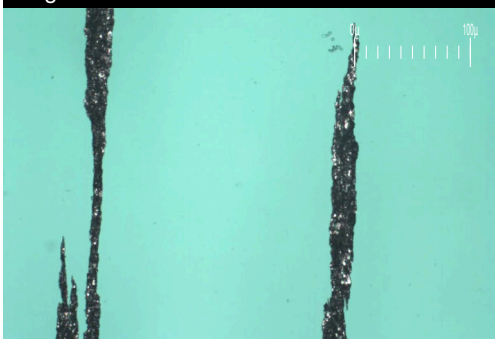
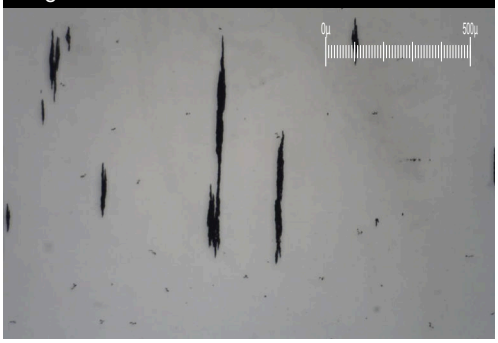
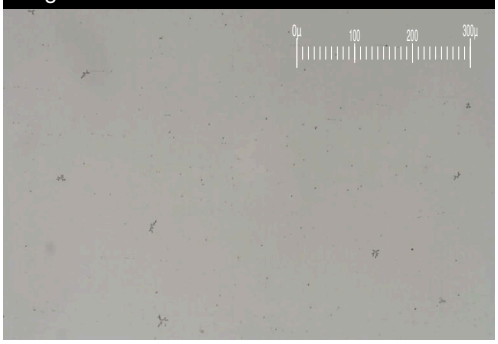
All component wear rates are normal. The ferrography results are normal indicating no abnormal wear in the system.
