OIL ANALYSIS REPORT

Area
SAB2
Machine Id
SAB2 G21 Governor
Component
Hydraulic System
Fluid
ESSO TERESSO ISO 46 (6160 LTR)

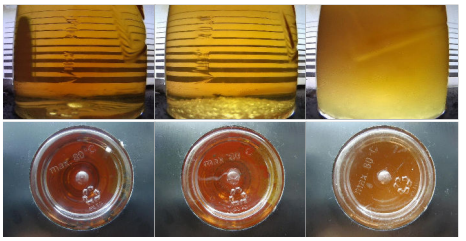
SAMPLE IMAGES	method	limit/base	current	history1	history2
Color					
Bottom

There is a moderate amount of particulates (2 to 100 microns in size) present in the oil. The system cleanliness is above the acceptable limit for the target ISO 4406 cleanliness code.

We advise that you perform a filter service, and use off-line filtration to improve the cleanliness of the system fluid. We recommend an early resample to monitor this condition. Please contact your representative for information regarding the proper sampling kits for your service. NOTE: We recommend using IND 3 test kits, this testkit includes Analytical Ferrography which provides a detailed morphological analysis of wear particles present in the fluid.
