OIL ANALYSIS REPORT

Area
SAB2
Machine Id
SAB2 G24
Component
Thrust Bearing
Fluid
ESSO TERESSO ISO 46 (5000 LTR)

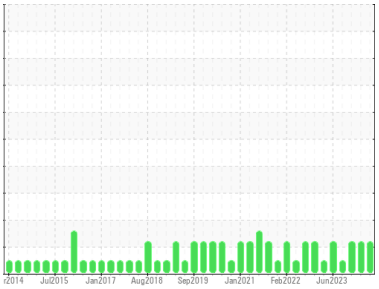
Sample Rating Trend

VISUAL METAL

Light concentration of visible metal present.

We advise that you check for visible metal particles in the oil. We recommend an early resample to monitor this condition. Please contact your representative for information regarding the proper sampling kits for your service. NOTE: We recommend using IND 3 test kits, this testkit includes Analytical Ferrography which provides a detailed morphological analysis of wear particles present in the fluid.

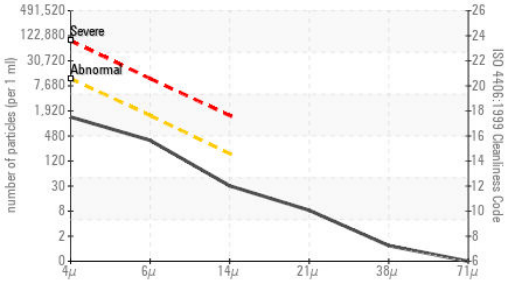
Particle Count

The system cleanliness is acceptable for your target ISO 4406 cleanliness code. The system and fluid cleanliness is acceptable.

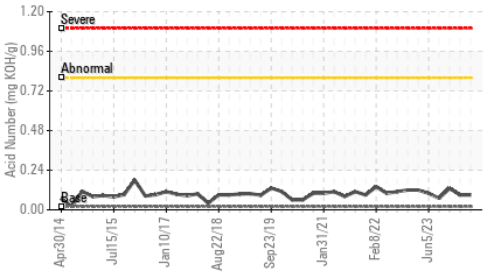
Acid Number

The AN level is acceptable for this fluid. The condition of the oil is suitable for further service.
