OIL ANALYSIS REPORT

Area
SAB2
Machine Id
SAB2 G26
Component
Thrust Bearing
Fluid
ESSO TERESSO ISO 46 (5000 LTR)

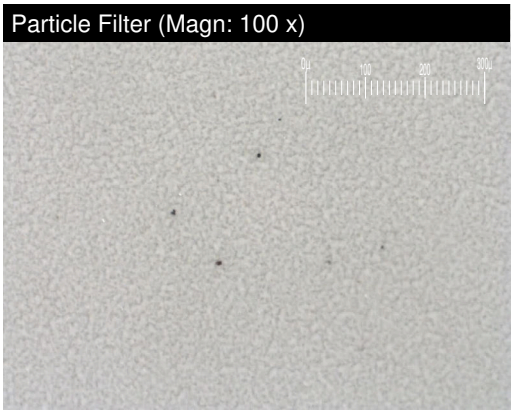
Particle Filter (Magn: 100 x)

Wear
Component wear rates appear to be normal (unconfirmed).

Contamination
The system cleanliness is acceptable for your target ISO 4406 cleanliness code. The system and fluid cleanliness is acceptable.

Recommendation
Resample at the next service interval to monitor. Please contact your representative for information regarding the proper sampling kits for your service. NOTE: We recommend using IND 3 test kits, this testkit includes Analytical Ferrography which provides a detailed morphological analysis of wear particles present in the fluid.

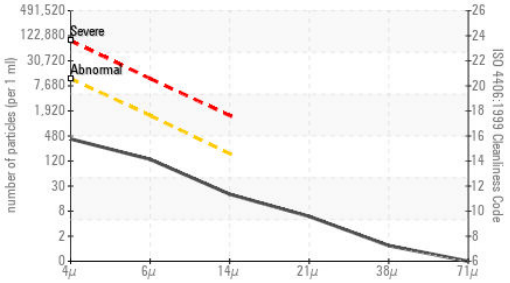
Particle Count

FLUID CLEANLINESS		method	limit/base	current	history1	history2
Particles >4µm		ASTM D7647	>10000	**358**	561	440
Particles >6µm		ASTM D7647	>1300	**116**	157	120
Particles >14µm		ASTM D7647	>160	**17**	15	7
Particles >21µm		ASTM D7647	>40	**5**	6	2
Particles >38µm		ASTM D7647	>10	**1**	1	1
Particles >71µm		ASTM D7647	>3	**0**	1	0
Oil Cleanliness		ISO 4406 (c)	>20/17/14	**16/14/11**	16/14/11	16/14/10

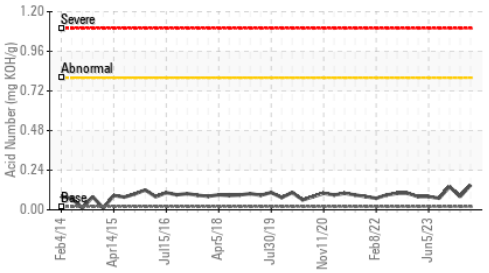
Fluid Condition
The AN level is acceptable for this fluid. The condition of the oil is suitable for further service.

FLUID DEGRADATION		method	limit/base	current	history1	history2
Acid Number (AN)	mg KOH/g	ASTM D974*	0.02	**0.15**	0.08	0.14

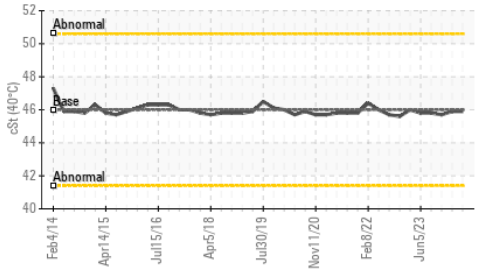
Viscosity @ 40°C

FLUID PROPERTIES		method	limit/base	current	history1	history2
Visc @ 40°C	cSt	ASTM D7279(m)	46	**45.9**	45.9	45.7
