OIL ANALYSIS REPORT

Area
(BL29648)
Machine Id
ISUZU RO366948
Component
Diesel Engine
Fluid
SAE 5W30 (--- GAL)

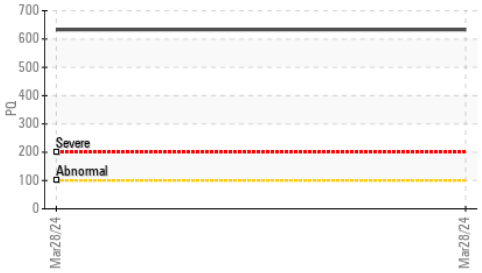
PQ levels are severe. Aluminum and iron ppm levels are abnormal. Light concentration of visible metal present. Piston, ring and cylinder wear is indicated. Cylinder, crank, or cam shaft wear is indicated. Piston wear is indicated. The very high ferrous density (PQ) index indicates that severe wear is occurring.

We advise that you check for visible metal particles in the oil. We recommend that you drain the oil from the component if this has not already been done. We recommend an early resample to monitor this condition.

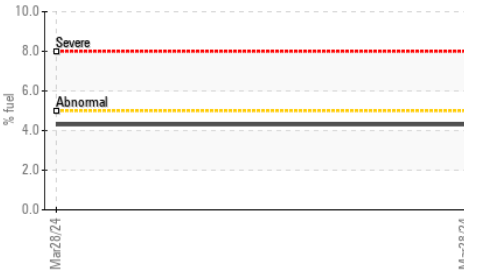
Fuel Dilution

Light fuel dilution occurring. No other contaminants were detected in the oil.

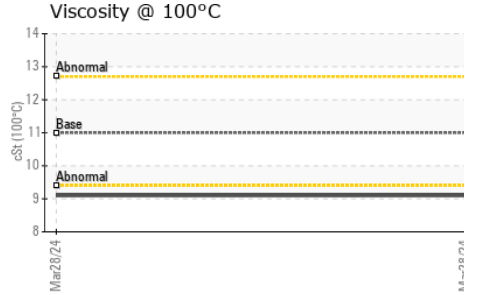
Viscosity @ 100°C

FLUID PROPERTIES		method	limit/base	current	history1	history2
Visc @ 100°C	cSt	ASTM D7279(m)	11.0	**9.1**	---	---
