OIL ANALYSIS REPORT

Machine Id
HONDA 1HGCYZF83PA800165
Component
Gasoline Engine
Fluid
HONDA 0W20 (--- GAL)

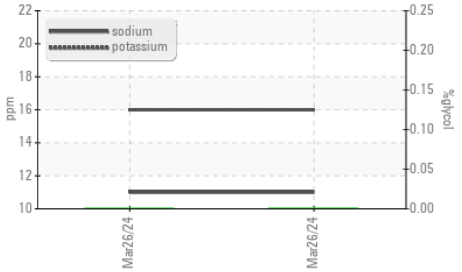
Glycol Contamination

There is a moderate concentration of water present in the oil. Free water present. Test for glycol is negative.

We advise that you check for the source of water entry. The oil change at the time of sampling has been noted. We recommend an early resample to monitor this condition.

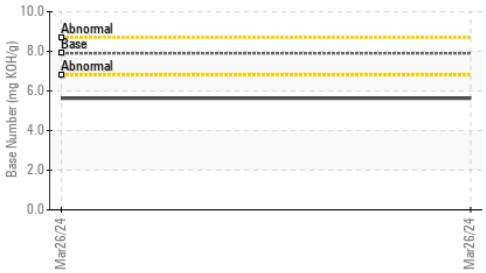
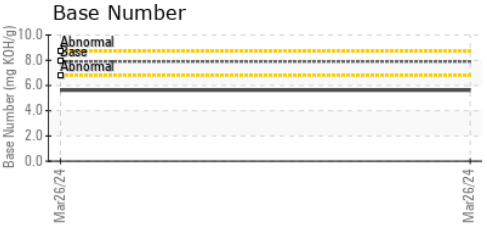
Base Number

The BN result indicates that there is suitable alkalinity remaining in the oil. Viscosity of sample indicates oil is within SAE 30 range, advise investigate. The oil is no longer serviceable due to the presence of contaminants.

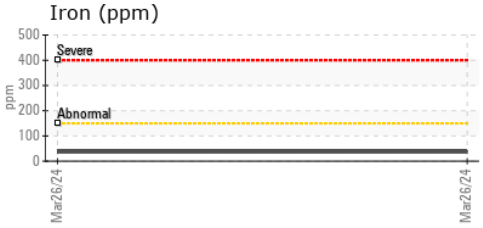
Iron (ppm)

Metal levels are typical for a new component breaking in.
