OIL ANALYSIS REPORT

Area
Goodyear - G04000
Machine Id
A2403165
Component
Hydraulic System
Fluid
AW HYDRAULIC OIL ISO 68 (--- GAL)

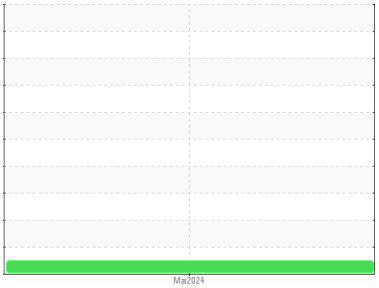
Sample Rating Trend

NORMAL

Wear
Copper, iron and lead ppm levels are noted.

Contamination
Silicon ppm levels are notably high.

Recommendation
We certify that this oil is clean, that the additives are acceptable, and that it is suitable for use.

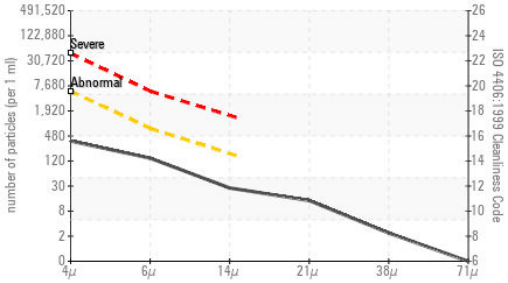
Particle Count

FLUID CLEANLINESS		method	limit/base	current	history1	history2
Particles >4µm		ASTM D7647	>5000	**319**	---	---
Particles >6µm		ASTM D7647	>640	**124**	---	---
Particles >14µm		ASTM D7647	>160	**24**	---	---
Particles >21µm		ASTM D7647	>40	**12**	---	---
Particles >38µm		ASTM D7647	>10	**2**	---	---
Particles >71µm		ASTM D7647	>3	**0**	---	---
Oil Cleanliness		ISO 4406 (c)	>19/16/14	**15/14/12**	---	---

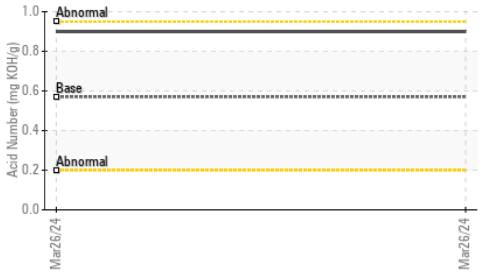
FLUID DEGRADATION		method	limit/base	current	history1	history2
Acid Number (AN)	mg KOH/g	ASTM D974*	0.57	**0.90**	---	---

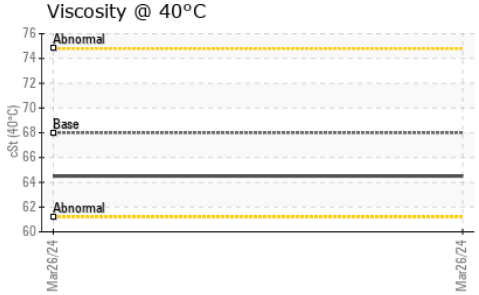
Viscosity @ 40°C

FLUID PROPERTIES		method	limit/base	current	history1	history2
Visc @ 40°C	cSt	ASTM D7279(m)	68	**64.5**	---	---
Visc @ 100°C	cSt	ASTM D7279(m)	8.6	**8.8**	---	---
Viscosity Index (VI)	Scale	ASTM D2270*	96	**109**	---	---
