OIL ANALYSIS REPORT

Area
Assy 787 NLG/Rig 13
Machine Id
DEC 6555
Component
Hydraulic System
Fluid
ESSO HYJET V (--- GAL)

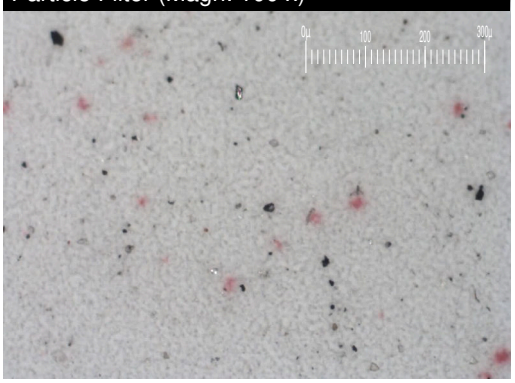
Particle Filter (Magn: 100 x)

Wear
Light concentration of visible metal present.

Contamination
There is a light amount of silt (particulates < 14 microns in size) present in the oil.

Recommendation
We advise that you check for visible metal particles in the oil. We recommend you service the filters on this component. We recommend an early resample to monitor this condition. NOTE: Please provide information regarding reservoir capacity, filter type and micron rating with next sample.

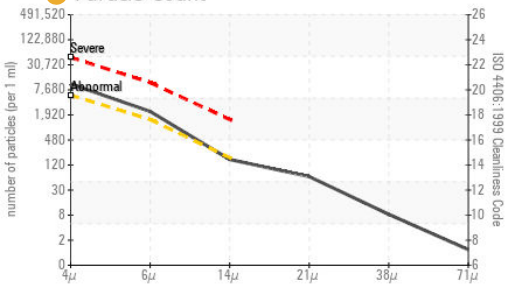
Particle Count

FLUID CLEANLINESS		method	limit/base	current	history1	history2
Particles >4µm		ASTM D7647	>5000	**9254**	1264	---
Particles >6µm		ASTM D7647	>1300	**2032**	203	---
Particles >14µm		ASTM D7647	>160	**144**	12	---
Particles >21µm		ASTM D7647	>40	**56**	3	---
Particles >38µm		ASTM D7647	>10	**7**	1	---
Particles >71µm		ASTM D7647	>3	**1**	1	---
Oil Cleanliness		ISO 4406 (c)	>19/17/14	**20/18/14**	17/15/11	---

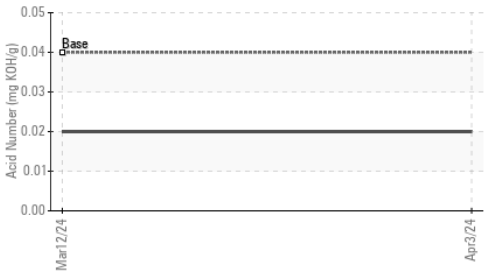
Fluid Condition
The AN level is acceptable for this fluid. The oil is still serviceable provided that the contaminant(s) can be reduced to acceptable levels.

FLUID DEGRADATION		method	limit/base	current	history1	history2
Acid Number (AN)	mg KOH/g	ASTM D974*	0.04	**0.02**	0.02	---
