Machine Id
PH632.010.17
Component
Port Hydraulic System
Fluid
PETRO CANADA ENDURATEX EP 150 (4500 LTR)

Customer Id: PLACHOPE
Sample No.: WC0873831
Lab Number: 02626979
Test Package: MAR 3

OIL ANALYSIS REPORT

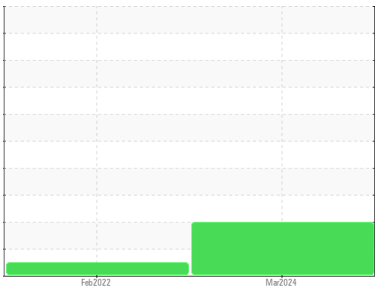
Sample Rating Trend

Sample Status				**SEVERE**	NORMAL	---
Particles >4µm		ASTM D7647	>5000	▲ **60012**	---	---
Particles >6µm		ASTM D7647	>1300	▲ **4915**	---	---
Oil Cleanliness		ISO 4406 (c)	>19/17/14	▲ **23/19/14**	---	---

Check seals and/or filters for points of contaminant entry. The air breather requires service. If unrated, we recommend that you replace with a suitable micron rated and/or desiccant air breather. If rated, we recommend that you service/replace the breather. We recommend you service the filters on this component. Resample in 30-45 days to monitor this situation. Please contact your representative for information regarding the proper sampling kits for your service. NOTE: We recommend using Advanced Oil Monitoring (AOM) kits for this system. The AOM test package includes advanced level testing to determine the suitability of turbine and large industrial compressor oils for continued use.

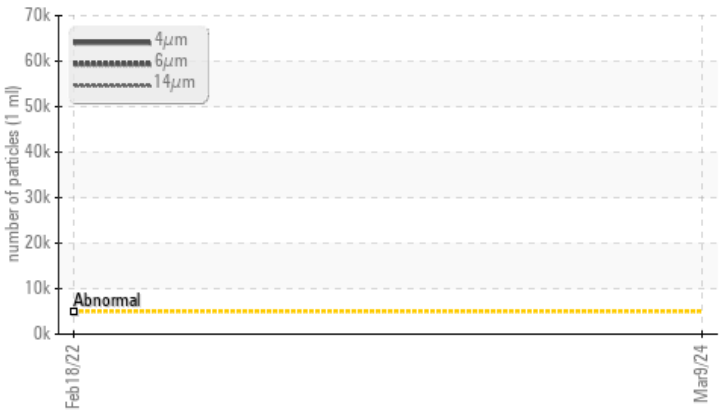
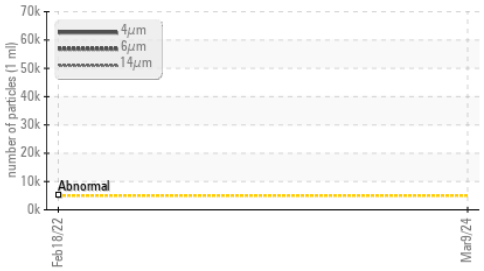
▲ Particle Trend

Contaminants
There is a high amount of silt (particulates < 14 microns in size) present in the oil.

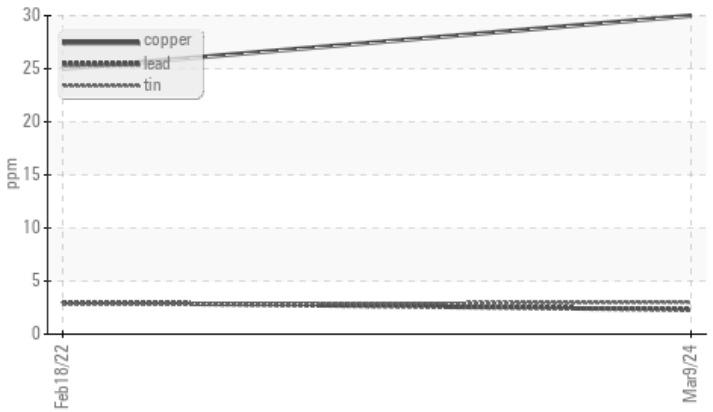
Non-ferrous Metals

Wear
All component wear rates are normal. The ferrography results are normal indicating no abnormal wear in the system.

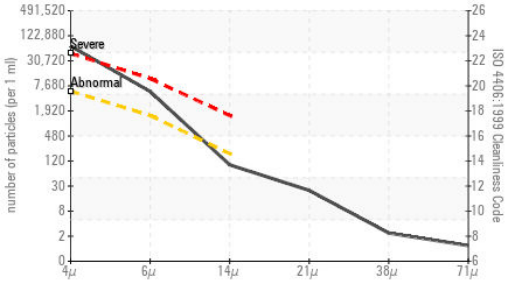
Particle Count

FLUID CLEANLINESS		method	limit/base	current	history1	history2
Particles >4µm		ASTM D7647	>5000	▲ **60012**	---	---
Particles >6µm		ASTM D7647	>1300	▲ **4915**	---	---
Particles >14µm		ASTM D7647	>160	**86**	---	---
Particles >21µm		ASTM D7647	>40	**21**	---	---
Particles >38µm		ASTM D7647	>10	**2**	---	---
Particles >71µm		ASTM D7647	>3	**1**	---	---
Oil Cleanliness		ISO 4406 (c)	>19/17/14	▲ **23/19/14**	---	---

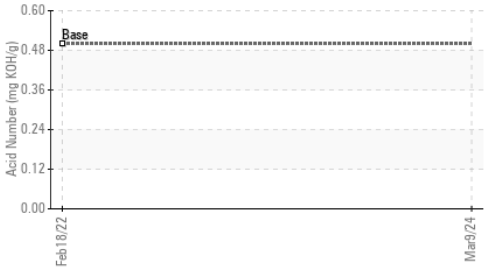
Oil Condition
The AN level is acceptable for this fluid. The condition of the oil is acceptable for the time in service (unconfirmed). The oil is still serviceable provided that the contaminant(s) can be reduced to acceptable levels.

FLUID DEGRADATION		method	limit/base	current	history1	history2
Acid Number (AN)	mg KOH/g	ASTM D974*	0.5	**0.39**	---	---

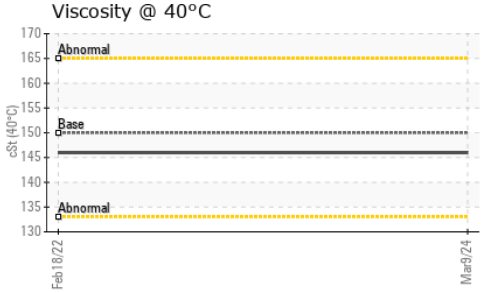
Viscosity @ 40°C

FLUID PROPERTIES		method	limit/base	current	history1	history2
Visc @ 40°C	cSt	ASTM D7279(m)	150.0	**146**	146	---

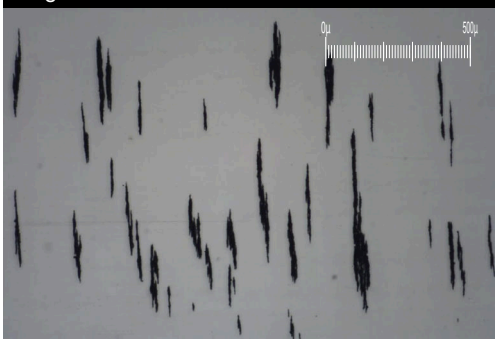
Magn: 50x Illum: RW

All component wear rates are normal. The ferrography results are normal indicating no abnormal wear in the system.
