OIL ANALYSIS REPORT

Machine Id
BOTTLE/DRILL #3
Component
Hydraulic System
Fluid
AW HYDRAULIC OIL ISO 46 (--- GAL)

Laboratory : WearCheck - C8-1175 Appleby Line, Burlington, ON L7L 5H9
Sample No. : WC0931322
Lab Number : 02628021
Unique Number : 5761153
Test Package : IND 2

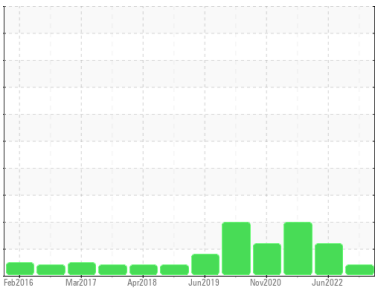
Sample Rating Trend

Fluid Condition
Viscosity of sample indicates oil is within ISO 32 range, advise investigate. The AN level is acceptable for this fluid. The condition of the oil is suitable for further service.

FLUID PROPERTIES		method	limit/base	current	history1	history2
Visc @ 40°C	cSt	ASTM D7279(m)	46	▲ **32.1**	▲ 32.2	▲ 32.2

Recommendation
Little or no information is provided as to the component and lubricant being tested. Recommendations are therefore generic in nature and may not apply to the current application. Please forward information as to equipment type, reservoir capacity, lubricant type and any pertinent information to allow for a more accurate assessment. Resample at the next service interval to monitor. NOTE: Please provide information regarding reservoir capacity, filter type and micron rating with next sample. Please specify the brand, type, and viscosity of the oil on your next sample.

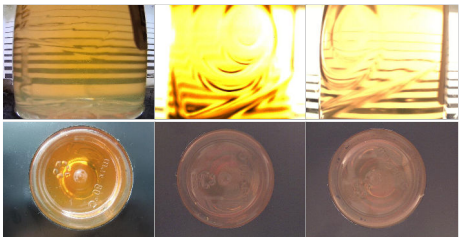
SAMPLE IMAGES	method	limit/base	current	history1	history2
Color					
Bottom

VISUAL		method	limit/base	current	history1	history2
White Metal	scalar	Visual*	NONE	**NONE**	NONE	NONE
Yellow Metal	scalar	Visual*	NONE	**NONE**	NONE	NONE
Precipitate	scalar	Visual*	NONE	**NONE**	NONE	NONE
Silt	scalar	Visual*	NONE	**NONE**	NONE	NONE
Debris	scalar	Visual*	NONE	**VLITE**	VLITE	VLITE
Sand/Dirt	scalar	Visual*	NONE	**NONE**	NONE	NONE
Appearance	scalar	Visual*	NORML	**NORML**	NORML	NORML
Odor	scalar	Visual*	NORML	**NORML**	NORML	NORML
Emulsified Water	scalar	Visual*	>0.05	**NEG**	NEG	NEG
Free Water	scalar	Visual*		**NEG**	NEG	NEG
