Area
Metelix - M10200
Machine Id
AG288
Component
Hydraulic System
Fluid
AW HYDRAULIC OIL ISO 46 (--- GAL)

Customer Id: CHECOB
Sample No.: E30001850
Lab Number: 02629615
Test Package: IND 2

OIL ANALYSIS REPORT

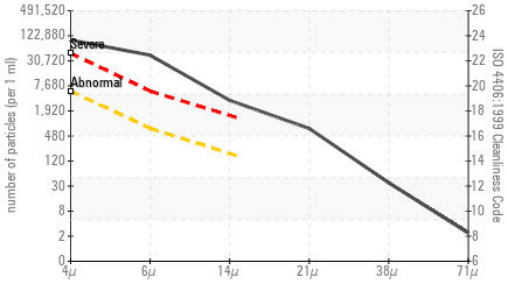
Particle Count

The sample submitted is 32 times dirtier than the ISO dirt count recommendation of 19/16/14.

Contamination
Particles >14µm are severely high. Particles >6µm are severely high. Oil Cleanliness are severely high. Particles >4µm are severely high. Particles >21µm are abnormally high. Particles >38µm are notably high.

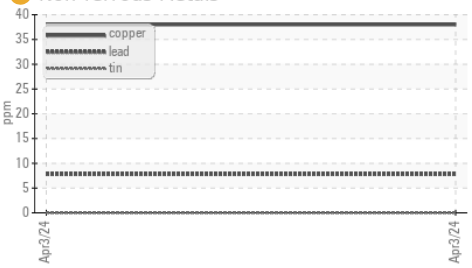
Non-ferrous Metals

Wear
Copper ppm levels are noted.

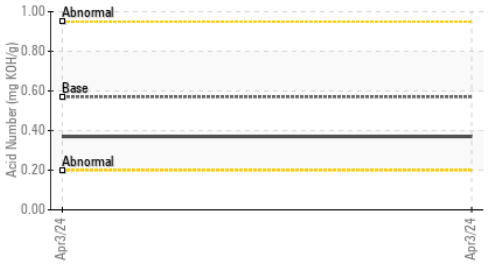
FLUID DEGRADATION		method	limit/base	current	history1	history2
Acid Number (AN)	mg KOH/g	ASTM D974*	0.57	**0.37**	---	---

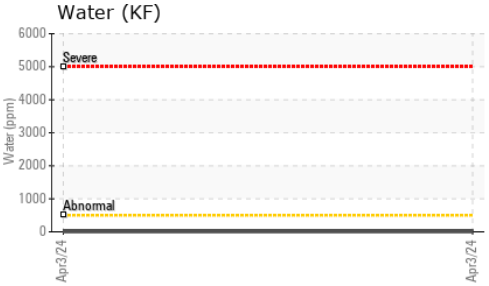
Water (KF)

CONTAMINANTS		method	limit/base	current	history1	history2
Silicon	ppm	ASTM D5185(m)	>15	**4**	---	---
Sodium	ppm	ASTM D5185(m)		**2**	---	---
Potassium	ppm	ASTM D5185(m)	>20	**<1**	---	---
Water	%	ASTM D6304*	>0.05	**0.001**	---	---
ppm Water	ppm	ASTM D6304*	>500	**6**	---	---
