Area
Royal Mat Inc. - 888043
Machine Id
XB125
Component
Hydraulic System
Fluid
APRIL SUPERFLO CLEAR AW HYDRAULIC OIL AW 68 (--- GAL)

Customer Id: CHECOB
Sample No.: E30001880
Lab Number: 02630207
Test Package: IND 2

OIL ANALYSIS REPORT

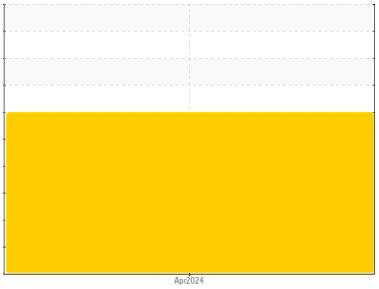
Sample Rating Trend

The sample submitted is 32 times dirtier than the ISO dirt count recommendation of 19/16/14.

Sample Status				**SEVERE**	---	---
Water	%	ASTM D6304*	>0.05	▲ **0.159**	---	---
ppm Water	ppm	ASTM D6304*	>500	▲ **1596**	---	---
Particles >4µm		ASTM D7647	>5000	▲ **99271**	---	---
Particles >6µm		ASTM D7647	>640	▲ **26009**	---	---
Particles >14µm		ASTM D7647	>160	▲ **695**	---	---
Particles >21µm		ASTM D7647	>40	▲ **127**	---	---
Oil Cleanliness		ISO 4406 (c)	>19/16/14	▲ **24/22/17**	---	---

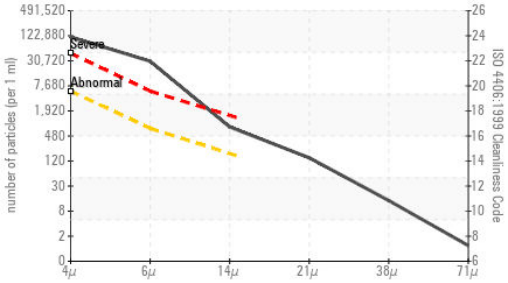
Particle Count

Contamination
Particles >6µm are severely high. Particles >4µm are severely high. Oil Cleanliness are severely high. Water and ppm water contamination levels are abnormal. Particles >14µm are abnormally high. Particles >21µm are notably high.

FLUID CLEANLINESS		method	limit/base	current	history1	history2
Particles >4µm		ASTM D7647	>5000	▲ **99271**	---	---
Particles >6µm		ASTM D7647	>640	▲ **26009**	---	---
Particles >14µm		ASTM D7647	>160	▲ **695**	---	---
Particles >21µm		ASTM D7647	>40	▲ **127**	---	---
Particles >38µm		ASTM D7647	>10	**12**	---	---
Particles >71µm		ASTM D7647	>3	**1**	---	---
Oil Cleanliness		ISO 4406 (c)	>19/16/14	▲ **24/22/17**	---	---

Recommendation
The sample submitted is 32 times dirtier than the ISO dirt count recommendation of 19/16/14.

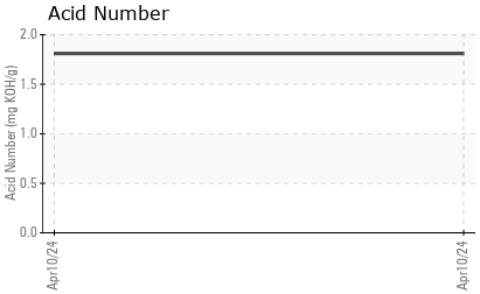
FLUID DEGRADATION		method	limit/base	current	history1	history2
Acid Number (AN)	mg KOH/g	ASTM D974*		**1.81**	---	---
