OIL ANALYSIS REPORT

Area
BD SHOP
Machine Id
200301
Component
Diesel Engine
Fluid
TEST OIL GOLD 4 (40 LTR)

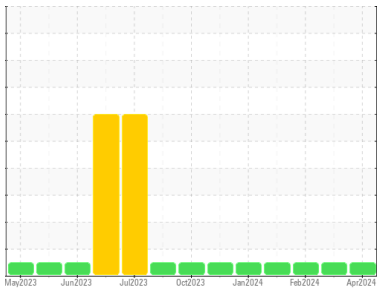
Sample Rating Trend

NORMAL

Wear
All component wear rates are normal.

Contamination
Elevated aluminum (Al) and/or lead (Pb) and potassium (K) levels in your metals analysis are likely a result of solder flux release into the lubricant and is common on new equipment/components. There is no indication of any contamination in the oil.

Fluid Condition
The BN result indicates that there is suitable alkalinity remaining in the oil. The condition of the oil is suitable for further service.

Recommendation
Resample at the next service interval to monitor.
