Area
Système de commande de gouvernail
Machine Id
12G02C1 - HPU Locking Pin
Component
Hydraulic System
Fluid
PETRO CANADA HYDREX AW 22 (--- GAL)

Customer Id: PIERRERAD
Sample No.: WC0866058
Lab Number: 02630593
Test Package: MAR 2

OIL ANALYSIS REPORT

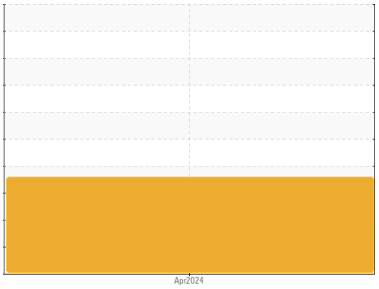
Sample Rating Trend

Sample Status				**SEVERE**	---	---
Particles >14µm		ASTM D7647	>160	▲ **586**	---	---
Particles >21µm		ASTM D7647	>40	▲ **322**	---	---
Oil Cleanliness		ISO 4406 (c)	>19/17/14	▲ **20/18/16**	---	---

Contamination
There is a high amount of particulates (2 to 100 microns in size) present in the oil.

We advise that you check all areas where contaminants can enter the system. We advise that you perform a filter service, and use off-line filtration to improve the cleanliness of the system fluid. The air breather requires service. If unrated, we recommend that you replace with a suitable micron rated and/or desiccant air breather. If rated, we recommend that you service/replace the breather. Resample in 30-45 days to monitor this situation. NOTE: Please provide information regarding reservoir capacity, filter type and micron rating with next sample.

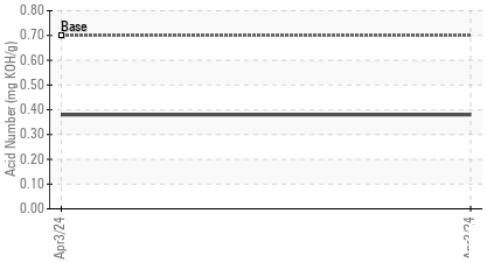
Fluid Condition
The AN level is acceptable for this fluid. The oil is still serviceable provided that the contaminant(s) can be reduced to acceptable levels.

FLUID DEGRADATION		method	limit/base	current	history1	history2
Acid Number (AN)	mg KOH/g	ASTM D974*	0.70	**0.38**	---	---

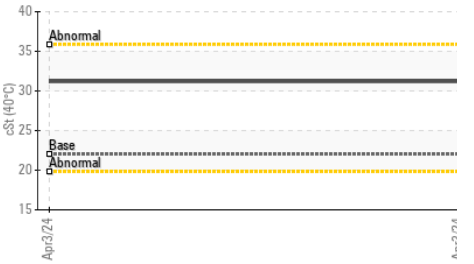
Viscosity @ 40°C

FLUID PROPERTIES		method	limit/base	current	history1	history2
Visc @ 40°C	cSt	ASTM D7279(m)	22.0	**31.2**	---	---

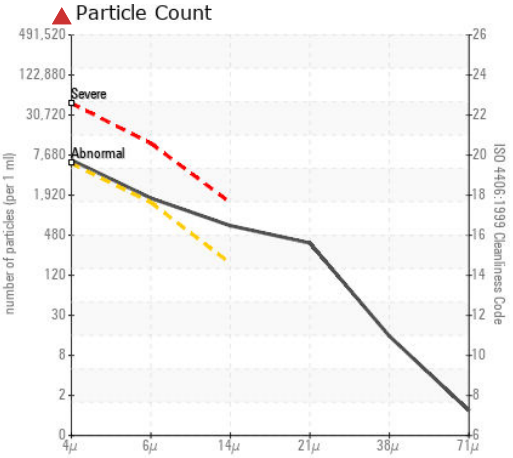
Particle Count

FLUID CLEANLINESS		method	limit/base	current	history1	history2
Particles >4µm		ASTM D7647	>5000	**5650**	---	---
Particles >6µm		ASTM D7647	>1300	**1513**	---	---
Particles >14µm		ASTM D7647	>160	**586**	---	---
Particles >21µm		ASTM D7647	>40	**322**	---	---
Particles >38µm		ASTM D7647	>10	**13**	---	---
Particles >71µm		ASTM D7647	>3	**1**	---	---
Oil Cleanliness		ISO 4406 (c)	>19/17/14	**20/18/16**	---	---
