Area
Integrity Tool and Mold - I06800
Machine ID
RB018
Component
Unknown Component
Fluid
DUBOIS MILPRO 830 CF (--- GAL)

Customer Id: CHECOB
Sample No.: E30002351
Lab Number: 02641115
Test Package: IND 2

OIL ANALYSIS REPORT

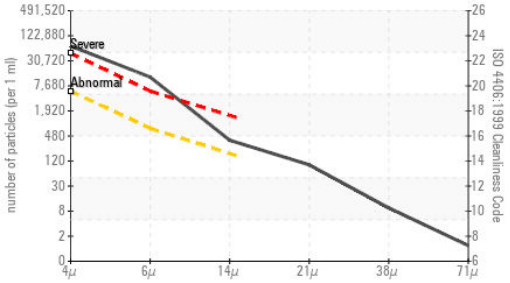
Particle Count

Contamination
Particles >6µm are severely high. Particles >4µm are severely high. Oil Cleanliness are severely high. Particles >14µm are abnormally high. Particles >21µm are abnormally high. Potassium ppm levels are notably high.

FLUID CLEANLINESS		method	limit/base	current	history1	history2
Particles >4µm		ASTM D7647	>5000	▲ **60248**	---	---
Particles >6µm		ASTM D7647	>640	▲ **10841**	---	---
Particles >14µm		ASTM D7647	>160	▲ **334**	---	---
Particles >21µm		ASTM D7647	>40	▲ **86**	---	---
Particles >38µm		ASTM D7647	>10	**8**	---	---
Particles >71µm		ASTM D7647	>3	**1**	---	---
Oil Cleanliness		ISO 4406 (c)	>19/16/14	▲ **23/21/16**	---	---

The sample submitted is 16 times dirtier than the ISO dirt count recommendation of 19/16/14.

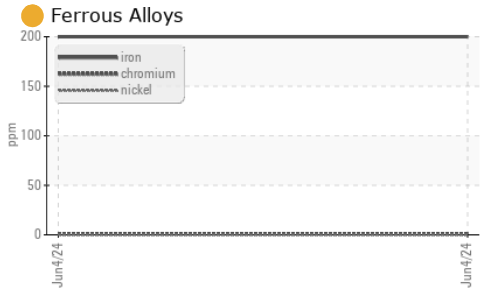
Ferrous Alloys

Wear
Aluminum, copper and iron ppm levels are noted.
