Customer Id: CHECOB
Sample No.: E30002340
Lab Number: 02641118
Test Package: IND 2

OIL ANALYSIS REPORT

Area
IMT Corporation - I02600
Machine Id
AM1011
Component
Quench Oil
Fluid
{not provided} (--- GAL)

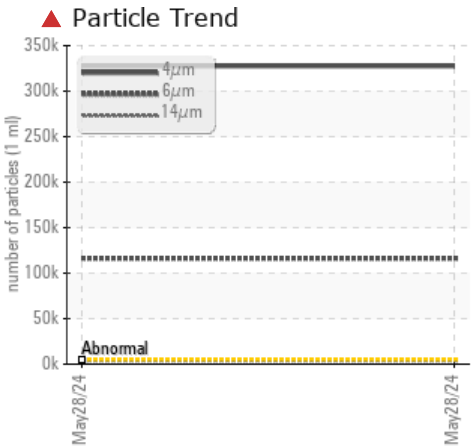
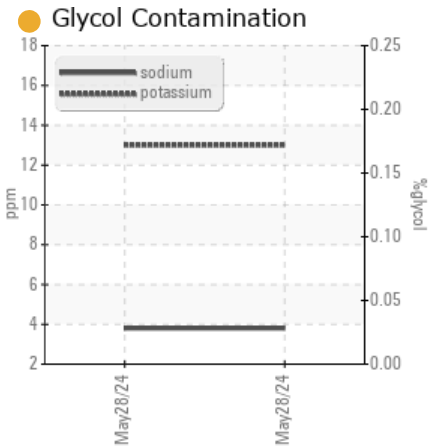
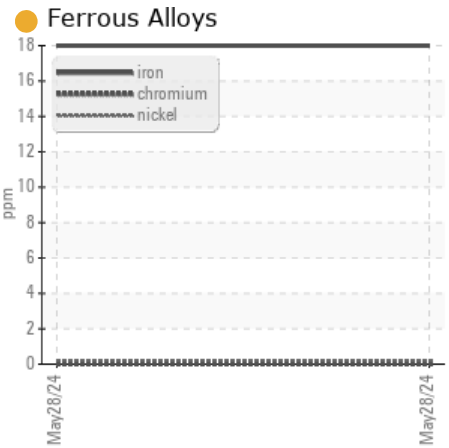
COMPONENT CONDITION SUMMARY

The sample submitted is 128 times dirtier than the ISO dirt count recommendation of 19/16/14.

Sample Status				**SEVERE**	---	---
Particles >4µm		ASTM D7647	>5000	▲ **327551**	---	---
Particles >6µm		ASTM D7647	>640	▲ **116202**	---	---
Particles >14µm		ASTM D7647	>160	▲ **3752**	---	---
Particles >21µm		ASTM D7647	>40	▲ **730**	---	---
Particles >38µm		ASTM D7647	>10	▲ **55**	---	---
Particles >71µm		ASTM D7647	>3	▲ **7**	---	---
Oil Cleanliness		ISO 4406 (c)	>19/16/14	▲ **26/24/19**	---	---

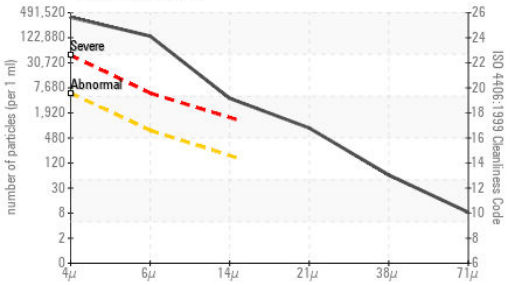
Particle Count

Contamination
Particles >14µm are severely high. Particles >21µm are severely high. Particles >6µm are severely high. Oil Cleanliness are severely high. Particles >4µm are severely high. Particles >38µm are abnormally high. Particles >71µm are abnormally high. Potassium ppm levels are notably high.

FLUID CLEANLINESS		method	limit/base	current	history1	history2
Particles >4µm		ASTM D7647	>5000	▲ **327551**	---	---
Particles >6µm		ASTM D7647	>640	▲ **116202**	---	---
Particles >14µm		ASTM D7647	>160	▲ **3752**	---	---
Particles >21µm		ASTM D7647	>40	▲ **730**	---	---
Particles >38µm		ASTM D7647	>10	▲ **55**	---	---
Particles >71µm		ASTM D7647	>3	▲ **7**	---	---
Oil Cleanliness		ISO 4406 (c)	>19/16/14	▲ **26/24/19**	---	---

Recommendation
The sample submitted is 128 times dirtier than the ISO dirt count recommendation of 19/16/14.

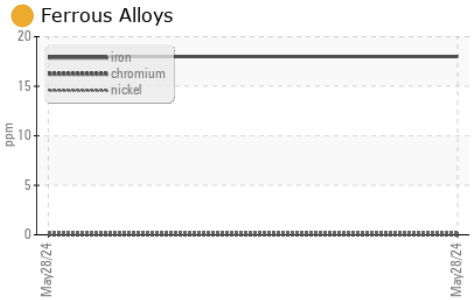
Ferrous Alloys

Wear
Iron ppm levels are noted.
