OIL ANALYSIS REPORT

Machine Id
TIMM #1 PLUNGER 1
Component
Gearbox
Fluid
SHELL OMALA S2 G 68 (--- GAL)

FERROGRAPHY REPORT

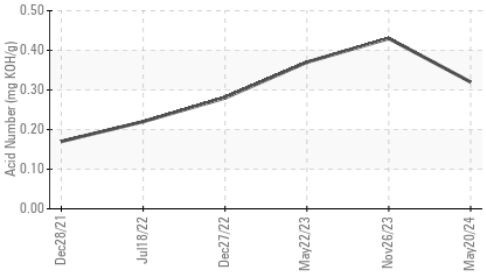
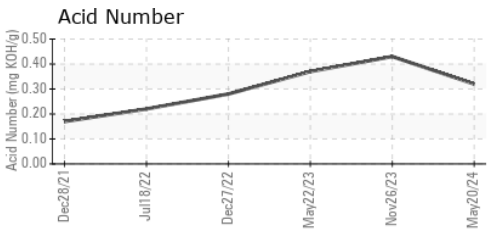
Oil Condition
The AN level is acceptable for this fluid. The condition of the oil is suitable for further service.

FLUID DEGRADATION		method	limit/base	current	history1	history2
Acid Number (AN)	mg KOH/g	ASTM D974*		**0.32**	0.43	0.37

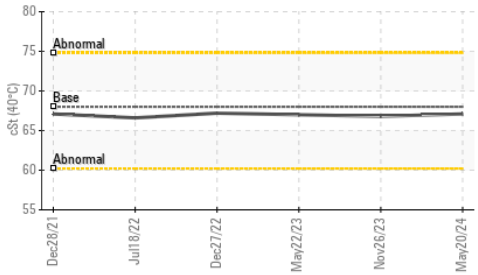
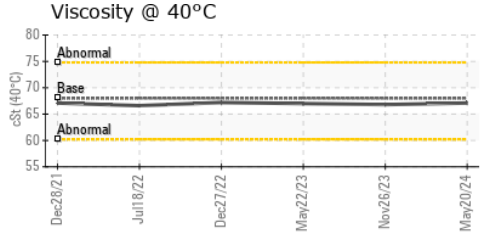
Viscosity @ 40°C

FLUID PROPERTIES		method	limit/base	current	history1	history2
Visc @ 40°C	cSt	ASTM D7279(m)	68.0	**67.1**	66.8	67.0

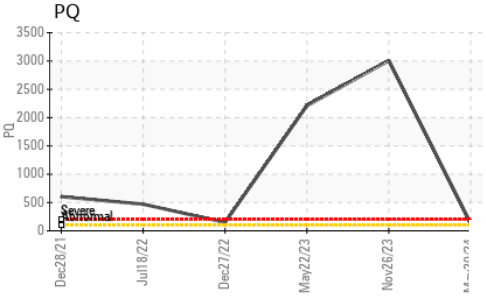
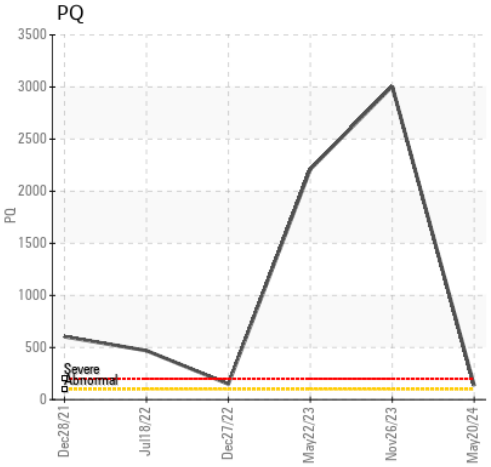
WEAR METALS		method	limit/base	current	history1	history2
PQ		ASTM D8184*		**134**	▲ 3007	▲ 2210
Iron	ppm	ASTM D5185(m)	>200	**121**	▲ 345	▲ 546
Chromium	ppm	ASTM D5185(m)	>15	**0**	<1	1
Nickel	ppm	ASTM D5185(m)	>15	**0**	0	0
Titanium	ppm	ASTM D5185(m)		**0**	0	0
Silver	ppm	ASTM D5185(m)		**0**	0	0
Aluminum	ppm	ASTM D5185(m)	>25	**<1**	<1	<1
Lead	ppm	ASTM D5185(m)	>100	**0**	<1	<1
Copper	ppm	ASTM D5185(m)	>200	**6**	12	12
Tin	ppm	ASTM D5185(m)	>25	**0**	0	0
Antimony	ppm	ASTM D5185(m)	>5	**0**	0	0
Vanadium	ppm	ASTM D5185(m)		**0**	0	0
Beryllium	ppm	ASTM D5185(m)		**0**	0	0
Cadmium	ppm	ASTM D5185(m)		**0**	0	0

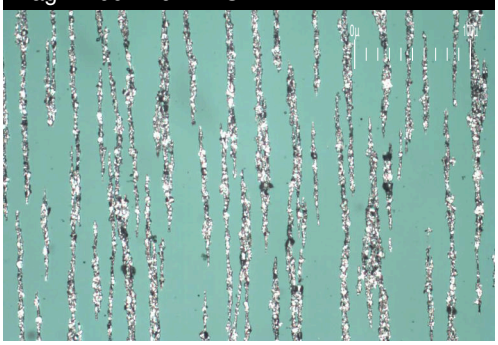
Magn: 200x Illum: BC

All component wear rates are normal. The ferrography results are normal indicating no abnormal wear in the system.
