OIL ANALYSIS REPORT

Machine Id
Temsa 2301
Component
Diesel Engine
Fluid
DIESEL ENGINE OIL SAE 10W30 (40)

Laboratory : WearCheck - C8-1175 Appleby Line, Burlington, ON L7L 5H9
Sample No. : WC0939765
Lab Number : 02641937
Unique Number : 5799476
Test Package : MOB 3

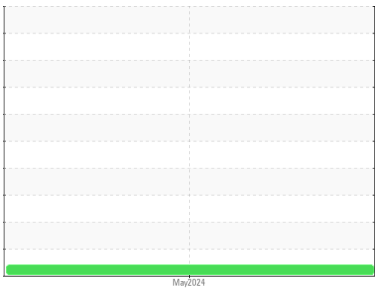
Sample Rating Trend

Oil Condition
The BN result indicates that there is suitable alkalinity remaining in the oil. Viscosity of sample indicates oil is within SAE 40 range, advise investigate. The condition of the oil is suitable for further service.

Recommendation
Resample at the next service interval to monitor.

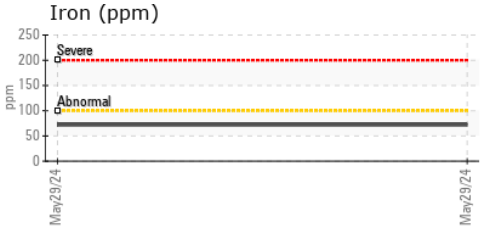
Iron (ppm)

Wear
All component wear rates are normal. The ferrography results are normal indicating no abnormal wear in the system.

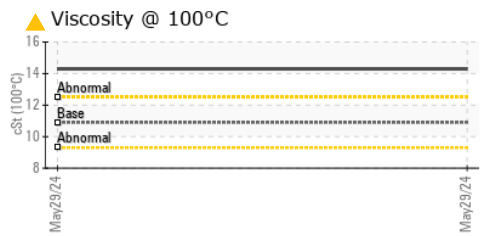
▲ Viscosity @ 100°C

FLUID PROPERTIES		method	limit/base	current	history1	history2
Visc @ 100°C	cSt	ASTM D7279(m)	10.9	▲ **14.3**	---	---

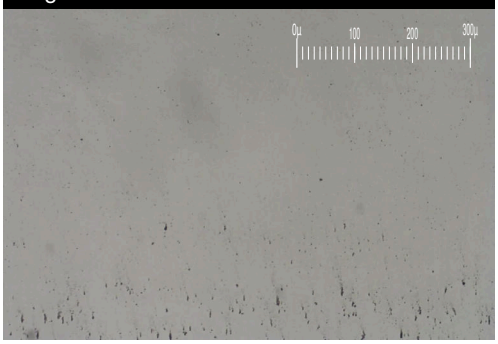
All component wear rates are normal. The ferrography results are normal indicating no abnormal wear in the system.
