OIL ANALYSIS REPORT

Area
BD SHOP
Machine Id
200294
Component
Diesel Engine
Fluid
TEST OIL GOLD 4 (40 LTR)

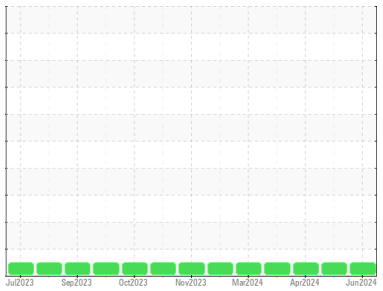
Sample Rating Trend

NORMAL

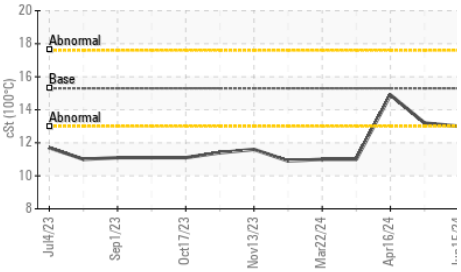
Viscosity @ 100°C

FLUID PROPERTIES		method	limit/base	current	history1	history2
Visc @ 100°C	cSt	ASTM D7279(m)	15.3	**13.0**	13.2	14.9

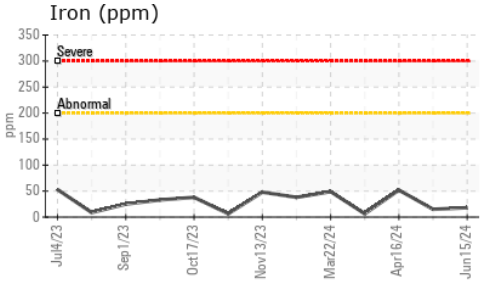
Iron (ppm)

Wear
All component wear rates are normal.

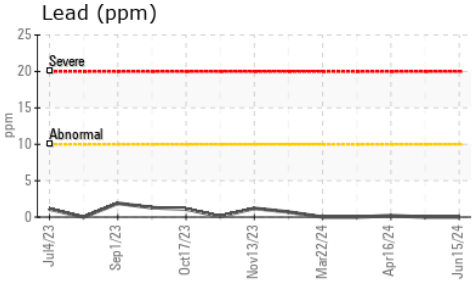
Lead (ppm)

Contamination
Elevated aluminum (Al) and/or lead (Pb) and potassium (K) levels in your metals analysis are likely a result of solder flux release into the lubricant and is common on new equipment/components. There is no indication of any contamination in the oil.

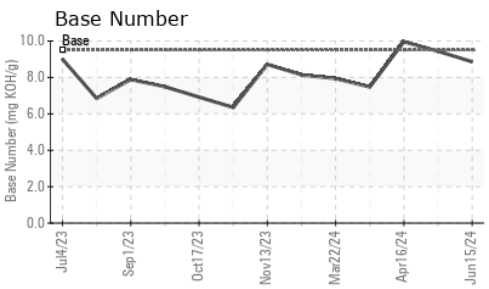
Base Number

Fluid Condition
The BN result indicates that there is suitable alkalinity remaining in the oil. The condition of the oil is suitable for further service.
