OIL ANALYSIS REPORT

Area
(C-GYHM)
Machine Id
003
Component
Hydraulic System
Fluid
ESSO HYJET IV-A PLUS (100 LTR)

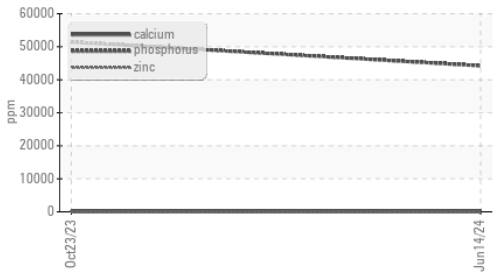
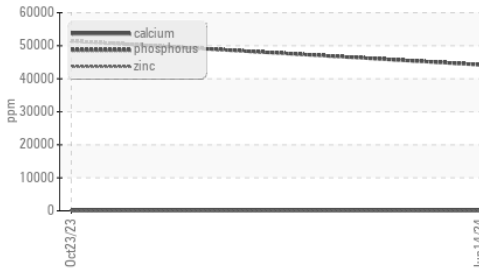
Additives

Fluid Condition
Additive levels indicate the addition of a different brand, or type of oil. The AN level is acceptable for this fluid. The condition of the oil is suitable for further service.

Recommendation
Confirm the source of the lubricant being utilized for top-up/fill. Resample at the next service interval to monitor.
