Customer Id: LEWBOSC
Sample No.: WC0956525
Lab Number: 02642692
Test Package: IND 2

OIL ANALYSIS REPORT

Area
RHOB/HYDRAULICS
Machine Id
E - 2 Hydraulics Repair Car
Component
Tank Hydraulic System
Fluid
FIRE-RESISTANT FLUID ISO 46 (132 GAL)

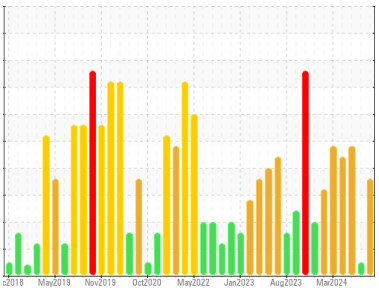
Sample Rating Trend

Sample Status				SEVERE	---	SEVERE
Particles >4µm		ASTM D7647	>5000	▲ **52180**	▲ 14408	▲ 125696
Particles >6µm		ASTM D7647	>1300	▲ **8568**	● 2464	▲ 12151
Particles >14µm		ASTM D7647	>160	▲ **694**	● 192	▲ 700
Particles >21µm		ASTM D7647	>40	▲ **249**	● 59	▲ 185
Particles >38µm		ASTM D7647	>10	▲ **25**	8	▲ 25
Particles >71µm		ASTM D7647	>3	▲ **6**	0	2
Oil Cleanliness		ISO 4406 (c)	>19/17/14	▲ **23/20/17**	▲ 21/18/15	▲ 24/21/17

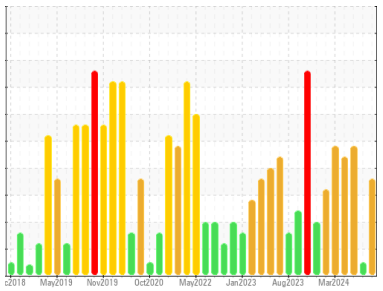
Sample Rating Trend

▲ Contamination
There is a high amount of particulates (2 to 100 microns in size) present in the oil.

▲ Recommendation
We advise that you check all areas where contaminants can enter the system. We advise that you perform a filter service, and use off-line filtration to improve the cleanliness of the system fluid. The air breather requires service. If unrated, we recommend that you replace with a suitable micron rated and/or desiccant air breather. If rated, we recommend that you service/replace the breather. Resample in 30-45 days to monitor this situation. Please specify the brand, type, and viscosity of the oil on your next sample.

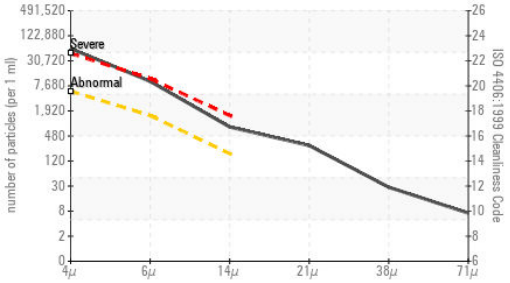
Particle Count

FLUID CLEANLINESS	method	limit/base	current	history1	history2
Particles >4µm	ASTM D7647	>5000	▲ **52180**	▲ 14408	▲ 125696
Particles >6µm	ASTM D7647	>1300	▲ **8568**	● 2464	▲ 12151
Particles >14µm	ASTM D7647	>160	▲ **694**	● 192	▲ 700
Particles >21µm	ASTM D7647	>40	▲ **249**	● 59	▲ 185
Particles >38µm	ASTM D7647	>10	▲ **25**	8	▲ 25
Particles >71µm	ASTM D7647	>3	▲ **6**	0	2
Oil Cleanliness	ISO 4406 (c)	>19/17/14	▲ **23/20/17**	▲ 21/18/15	▲ 24/21/17

We advise that you check all areas where contaminants can enter the system. We advise that you perform a filter service, and use off-line filtration to improve the cleanliness of the system fluid. The air breather requires service. If unrated, we recommend that you replace with a suitable micron rated and/or desiccant air breather. If rated, we recommend that you service/replace the breather. Resample in 30-45 days to monitor this situation. Please specify the brand, type, and viscosity of the oil on your next sample.

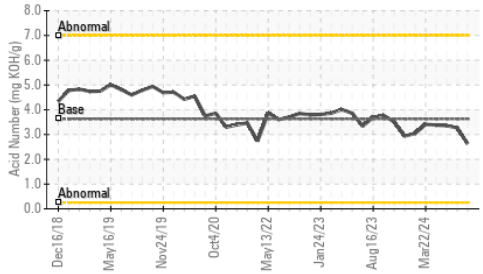
FLUID DEGRADATION		method	limit/base	current	history1	history2
Acid Number (AN)	mg KOH/g	ASTM D974*	3.63	**2.63**	3.27	3.36
Alkiline Reserve (Oils)	ml KOH/g	ASTM D1121*		**208**	192	210

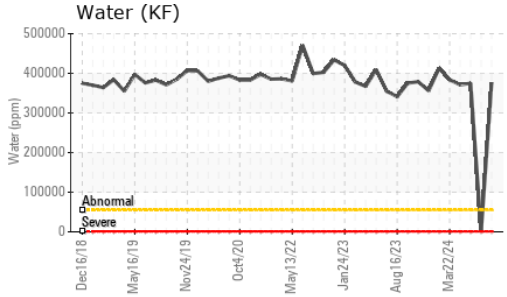
Water (KF)

CONTAMINANTS		method	limit/base	current	history1	history2
Silicon	ppm	ASTM D5185(m)	>15	**2**	1	2
Sodium	ppm	ASTM D5185(m)		**187**	230	178
Potassium	ppm	ASTM D5185(m)	>20	**20**	90	17
Water	%	ASTM D6304*	>55	**37.6**	---	37.5
ppm Water	ppm	ASTM D6304*	>55000	**376000**	---	375000
